# Access Compliance Report

## Public Rights-of-Way

### (Curb Ramps)

| Intersection ID: 15859 | Main Street: CHAR_MECK_LN | Cross Street: MCALWAY RD | Location: SW |

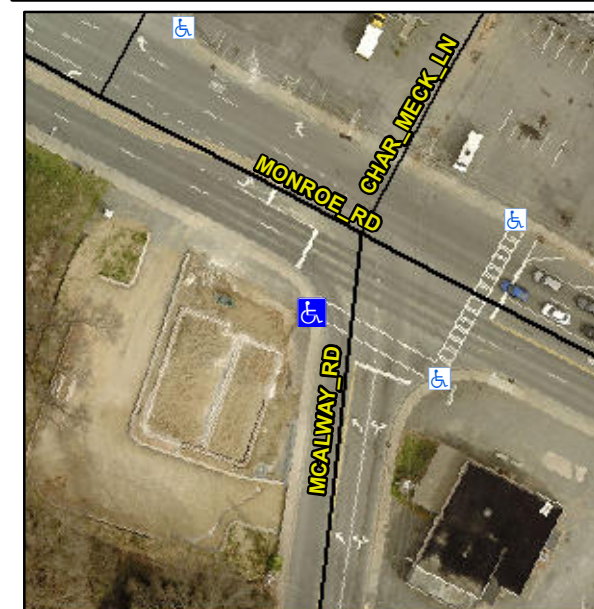
**Not Found, R304.5.1, R304.2.2, R304.5.3**

| Compliance | Description | Data | Compliance | Description | Data |
|---|---|---|---|---|---|
| N/A | Ramp Length (in) | 56.0 | No | Ramp Slope (%) | 8.7 |
| No | Ramp Width (in) | 43.0 | No | Ramp XSlope (%) | 3.8 |

**Remove & Replace Curb Ramp With Two New Directional Ramps or Equivalent.**

Total Cost: \$ 3200.00
