Access Compliance Report

Public Rights-of-Way

(Curb Ramps)

Intersection ID: 24411	Main Street: CAMAROSS_DR	Cross Street: ELPHIN_CT	Location:	E
ADA ID: 6E115880A18A	Ramp Type: Perp	Initial Pass/Fail: Fail	Overall Compliance: No	Severity Score: 12.5

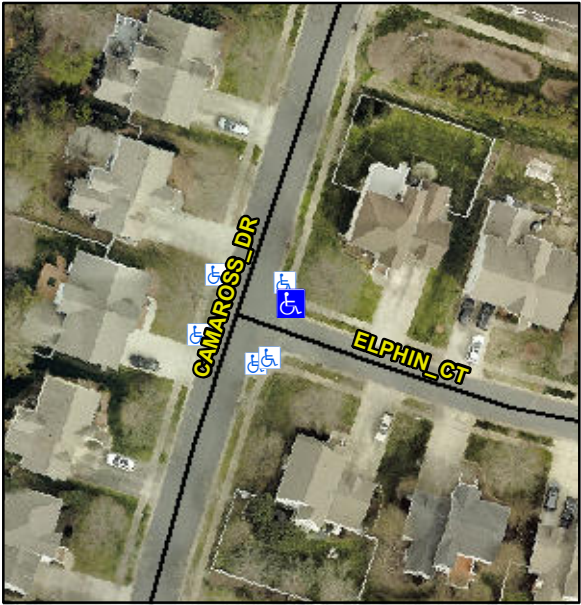
Possible Solutions:		Compliance	Description	Data
	Remove & Replace Entire Ramp.		N/A	Ramp Length (in)	48.0
			Yes	Ramp Width (in)	48.0
			N/A	Flare Type LT	N/A
			N/A	Flare Slope LT (%)	N/A
			N/A	Flare Traversable LT?	N/A
			N/A	Landing Length (in)	N/A
			N/A	Landing Width (in)	N/A
			N/A	Landing Slope (%)	N/A
			N/A	Landing X Slope (%)	N/A
<p>Surveyor Notes:</p> <p>N/A</p> <p>PROW/ADA:</p> <p>Not Found, R304.2.2</p>			N/A	Flare Type RT	N/A
			N/A	Flare Slope RT (%)	N/A
			N/A	Flare Traversable RT?	N/A
			N/A	DWS Provided?	N/A
			N/A	DWS Contrast?	N/A
			N/A	DWS Length (in)	N/A
			N/A	DWS Full Width?	N/A
			N/A	DWS Offset (in)	N/A
			N/A	Shared Landing?	N/A
			N/A	Gutter Ponding?	N/A
			N/A	Gutter Lip Ht (in)	N/A
			N/A	Painted X Walk1?	No
				X Walk 1 Direction	To SW
			N/A	X Walk 1 Width (in)	N/A
				X Walk 1 Slope (%)	4.9
				X Walk 1 X Slope (%)	0.3

N/A	Ramp inside XWalk1?	N/A
			N/A	Road Slope (%)	N/A
			N/A	Road X Slope (%)	N/A
			N/A	Any Obstructions?	N/A
				Obstruction Type	
Total Cost:			\$	1850.00
