# Access Compliance Report

## Public Rights-of-Way

| Intersection ID: 10379 | Main Street: ANDERSON_ST | Cross Street: E_SUGAR_CREEK_RD | Location: S |
| ADA ID: 6E1E8D64CFA5 | Ramp Type: PerpDiag | Initial Pass/Fail: Fail | Overall Compliance: No |

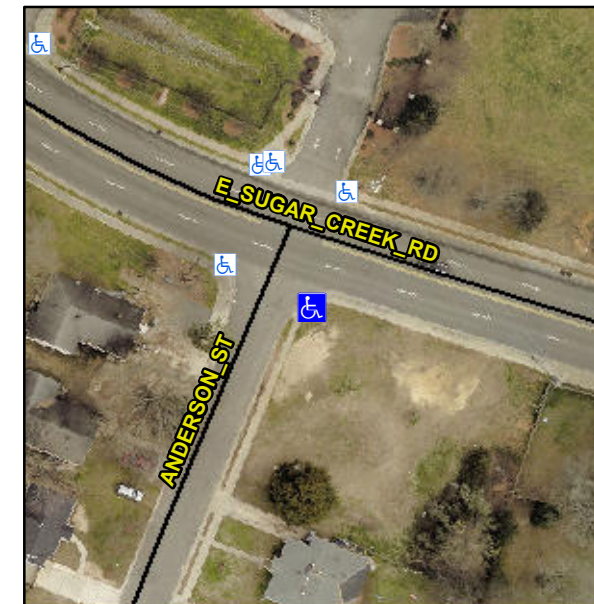
| | | Severity Score: 10 | |

**Not Found, R304.5.1, R304.5.3**

| Compliance | Description | Data | Compliance | Description | Data |
|---|---|---|---|---|---|
| N/A | Ramp Length (in) | 58.0 | Yes | Ramp Slope (%) | 6.8 |
| No | Ramp Width (in) | 42.5 | No | Ramp XSlope (%) | 3.4 |

**Remove & Replace Curb Ramp With Two New Directional Ramps or Equivalent.**

Total Cost: \$ 3200.00
