## **Access Compliance Report Public Rights-of-Way** (Curb Ramps)

Intersection ID: 11102 Main Street: TUCKASEEGEE RD **Cross Street: JAY ST** Location: SE

Initial Pass/Fail: Fail **Overall Compliance: No** ADA ID: 6E478F8B3C07 Ramp Type: PerpDiag Severity Score: 13.75

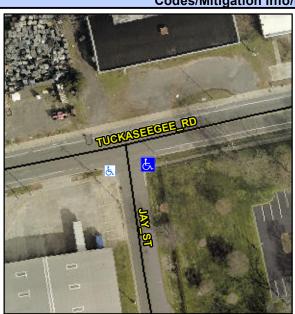
**TUCKASEEGEE RD** Street 1 Name Stop Condition-Street 2 None **JAY ST** Street 2 Name Stop Condition-Street 1 StopSign Possible Solutions: Compliance Description Remove & Replace Curb Ramp With Two New Directional Ramps or Equivalent. Surveyor Notes: N/A PROW/ADA: Not Found, R304.2.2, R304.5.3
