Access Compliance Report

Public Rights-of-Way

(Curb Ramps)

Intersection ID: 15116	Main Street: EUCLID_AV	Cross Street: IDEAL_WY	Location:	N
ADA ID: 6E4A70EC82D1	Ramp Type: Perp	Initial Pass/Fail: Fail	Overall Compliance: No	Severity Score: 1.25
Codes/Mitigation Info/Possible Solution		Field Measurements/Component Compliance

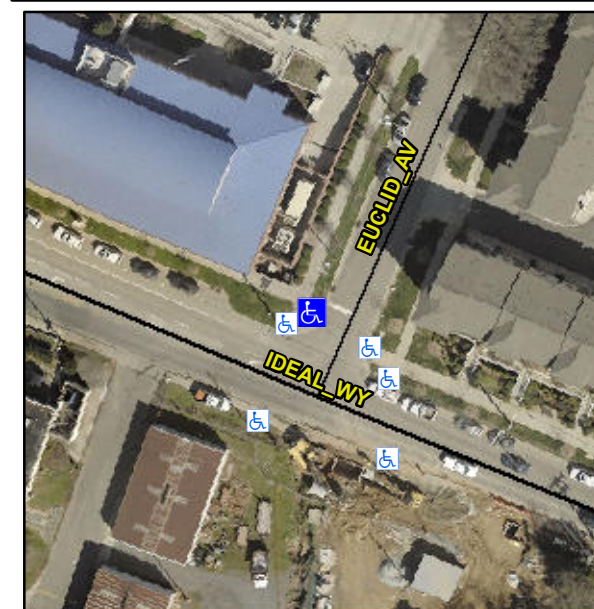
Compliance	Description	Data	Compliance	Description	Data
N/A	Ramp Length (in)	78.0	Yes	Ramp Slope (%)	7.6
Yes	Ramp Width (in)	71.0	No	Ramp XSlope (%)	3.4
N/A	Flare Type LT	N/A	N/A	Flare Type RT	N/A
N/A	Flare Slope LT (%)	N/A	N/A	Flare Slope RT (%)	N/A
N/A	Flare Traversable LT?	N/A	N/A	Flare Traversable RT?	N/A
N/A	Landing Length (in)	N/A	N/A	DWS Provided?	N/A
N/A	Landing Width (in)	N/A	N/A	DWS Contrast?	N/A
N/A	Landing Slope (%)	N/A	N/A	DWS Length (in)	N/A
N/A	Landing X Slope (%)	N/A	N/A	DWS Full Width?	N/A
N/A	Landing Curb? (Y/N)	N/A	N/A	DWS Offset (in)	N/A
N/A	Shared Landing?	N/A			
N/A	Gutter Ponding?	N/A	N/A	Gutter Slope (%)	N/A
N/A	Gutter Lip Ht (in)	1.0	N/A	Gutter X Slope (%)	N/A
N/A	Painted X Walk1?	No	N/A	Painted X Walk2?	N/A
	X Walk 1 Direction	To SE		X Walk 2 Direction	N/A
N/A	X Walk 1 Width (in)	N/A	N/A	X Walk 2 Width (in)	N/A
	X Walk 1 Slope (%)	1.2		X Walk 2 Slope (%)	N/A
	X Walk 1 X Slope (%)	7.4		X Walk 2 X Slope (%)	N/A

N/A	Ramp inside XWalk1?	N/A	N/A	Ramp inside XWalk2?	N/A
	Road Slope (%)	N/A	N/A	Clear Space?	N/A
	Road X Slope (%)	N/A	N/A	Clear Space to XWalk (in)	N/A
N/A	Any Obstructions?	N/A	N/A	Storm Grate/Utility Hazard?	N/A
	Obstruction Type			Storm Grate/Utility Type	
		N/A			N/A
			Yes	Surface Condition? (G/P)	Good

Possible Solutions:

Remove & Replace Entire Ramp.

R304.5.3

\$ 1850.00
