Access Compliance Report

Public Rights-of-Way

(Curb Ramps)

Intersection ID: N/A	Main Street: MORABLIN_DR	Cross Street: COSTIGAN_LN	Location: W
ADA ID: 6E4CCCBEEED0D	Ramp Type: Perp	Initial Pass/Fail: Fail	Overall Compliance: No
Codes/Mitigation Info/Possible Solution		Field Measurements/Component Compliance

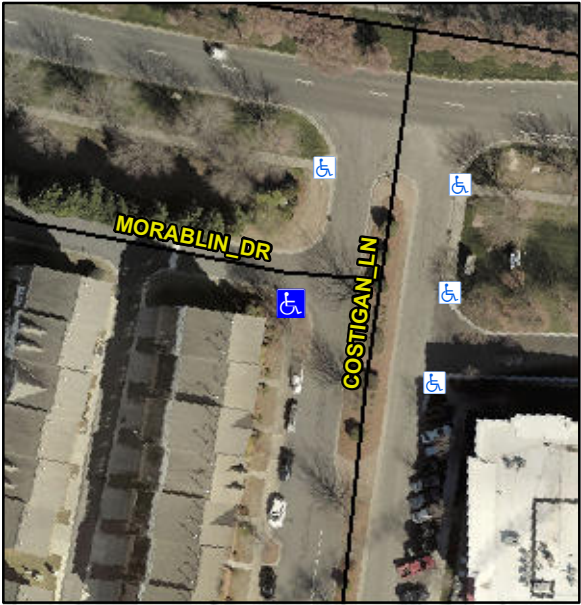
Possible Solutions:						
	Remove & Replace Entire Ramp.						
	Surveyor Notes:						
	N/A						
	PROW/ADA:						
	R304.2.2, R304.5.3						
	Street 1 Name	MORABLIN DR					
	Stop Condition-Street 2	StopSign					
	Street 2 Name	N/A					
	Stop Condition-Street 1	N/A					
	Total Cost:	\$ 1850.00					
			Compliance	Description	Data	Compliance	Description
			N/A	Ramp Length (in)	45.0	No	Ramp Slope (%)
			Yes	Ramp Width (in)	48.0	No	Ramp XSlope (%)
			N/A	Flare Type LT	N/A	N/A	Flare Type RT
			N/A	Flare Slope LT (%)	N/A	N/A	Flare Slope RT (%)
			N/A	Flare Traversable LT?	N/A	N/A	Flare Traversable RT?
			N/A	Landing Length (in)	N/A	N/A	DWS Provided?
			N/A	Landing Width (in)	N/A	N/A	DWS Contrast?
			N/A	Landing Slope (%)	N/A	N/A	DWS Length (in)
			N/A	Landing X Slope (%)	N/A	N/A	DWS Full Width?
			N/A	Landing Curb? (Y/N)	N/A	N/A	DWS Offset (in)
			N/A	Shared Landing?	N/A		
			N/A	Gutter Ponding?	N/A	N/A	Gutter Slope (%)

N/A	Gutter Lip Ht (in)	N/A	N/A	Gutter X Slope (%)
			N/A	Painted X Walk1?	No	N/A	Painted X Walk2?
				X Walk 1 Direction	To NE		X Walk 2 Direction
			N/A	X Walk 1 Width (in)	N/A	N/A	X Walk 2 Width (in)
				X Walk 1 Slope (%)	3.3		X Walk 2 Slope (%)
				X Walk 1 X Slope (%)	1.9		X Walk 2 X Slope (%)
			N/A	Ramp inside XWalk1?	N/A	N/A	Ramp inside XWalk2?
				Road Slope (%)	N/A	N/A	Clear Space?
				Road X Slope (%)	N/A	N/A	Clear Space to XWalk (in)
			N/A	Any Obstructions?	N/A	N/A	Storm Grate/Utility Hazard?
				Obstruction Type			Storm Grate/Utility Type
					N/A		N/A
					Yes		Surface Condition? (G/P)
							Good
