Access Compliance Report

Public Rights-of-Way

(Curb Ramps)

Intersection ID: 23963	Main Street: GREYLEAF_PL	Cross Street: LONGLEAF_DR	Location: NE
ADA ID: 6E4E4860F6D4	Ramp Type: Directional1	Initial Pass/Fail: Fail	Overall Compliance: No
Codes/Mitigation Info/Possible Solution			Severity Score: 25
			Field Measurements/Component Compliance

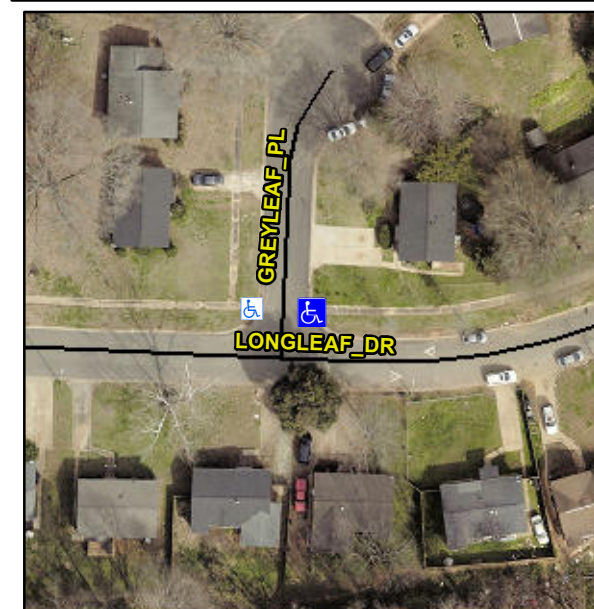
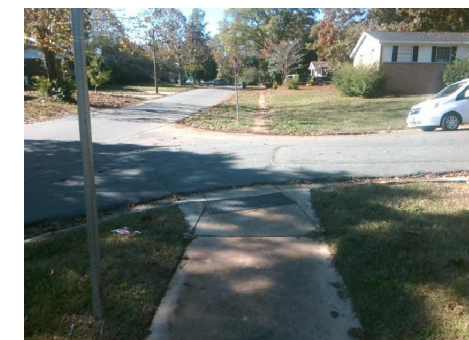
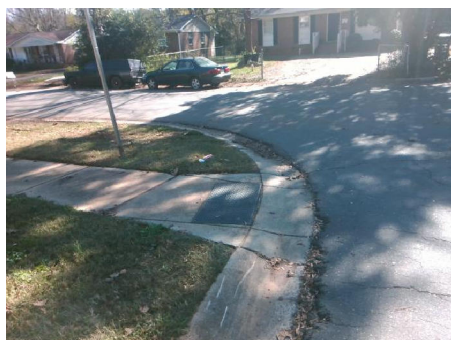
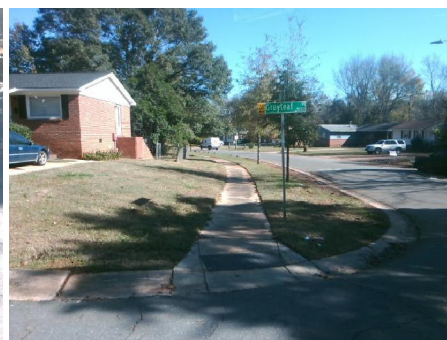
ASP LIP 2.0"

PROW/ADA:

R304.5.3

Compliance	Description	Data	Compliance	Description	Data
N/A	Ramp Length (in)	55.0	N/A	Grade Break?	N/A
Yes	Ramp Width (in)	53.0	N/A	Grade Break Slope (%)	0.0
Yes	Ramp Slope (%)	1.9	N/A	Grade Break XSlope (%)	0.0
No	Ramp XSlope (%)	7.3			
N/A	Flare Type LT	N/A	N/A	Flare Type RT	N/A
N/A	Flare Slope LT (%)	N/A	N/A	Flare Slope RT (%)	0.0
N/A	Flare Traversable LT?	N/A	N/A	Flare Traversable RT?	N/A
N/A	Landing Length (in)	0.0	N/A	DWS Provided?	N/A
N/A	Landing Width (in)	0.0	N/A	DWS Contrast?	N/A
N/A	Landing Slope (%)	0.0	N/A	DWS Length (in)	N/A
N/A	Landing X Slope (%)	0.0	N/A	DWS Full Width?	N/A
N/A	Landing Curb? (Y/N)	N/A	N/A	DWS Offset LT (in)	N/A
N/A	Shared Landing?	N/A	N/A	DWS Offset RT (in)	N/A
N/A	Gutter Ponding?	0.0	N/A	Gutter Slope (%)	N/A
N/A	Gutter Lip Ht (in)	0.0	N/A	Gutter X Slope (%)	N/A
N/A	Painted X Walk1?	No		Road Slope (%)	5.1
	X Walk 1 Direction	To W		Road X Slope (%)	3.5
	X Walk 1 Width (in)	N/A		Clear Space?	N/A

X Walk 1 Slope (%)	5.1	N/A	Clear Space to XWalk (in)	N/A
	X Walk 1 X Slope (%)	3.5	N/A	Storm Grate/Utility Hazard?	N/A
N/A	Ramp inside XWalk1?	N/A		Storm Grate/Utility Type	
N/A	Any Obstructions?	N/A			N/A
	Obstruction Type		Yes	Surface Condition? (G/P)	Good
			N/A	Curb Slope (%)	7.2

Possible Solutions:

Remove & Replace Entire Ramp.

Total Cost:

\$ 1600.00
