Access Compliance Report

Public Rights-of-Way

(Curb Ramps)

Intersection ID: 10033070	Main Street: NORTH_COMMUNITY_HOUSE_RD	Cross Street: N/A	Location: NW
ADA ID: 6E555BCA4FF1	Ramp Type: Perp	Initial Pass/Fail: Fail	Overall Compliance: No
Codes/Mitigation Info/Possible Solution		Field Measurements/Component Compliance	
Severity Score: 12.5

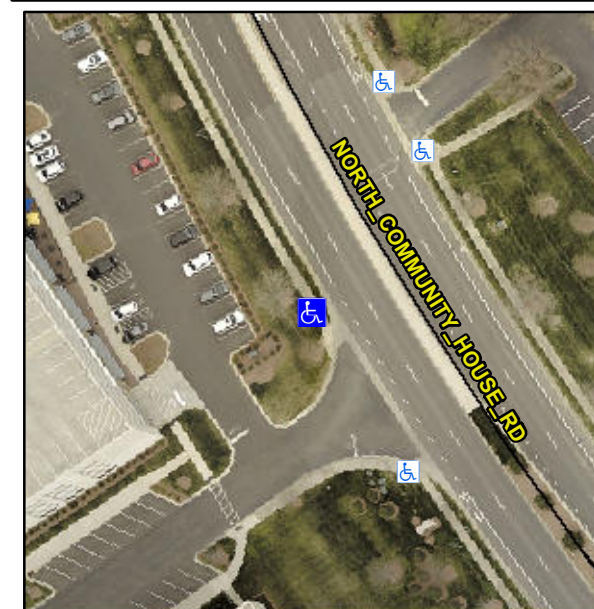
Not Found, R304.2.2

Compliance	Description	Data	Compliance	Description	Data
N/A	Ramp Length (in)	60.0	No	Ramp Slope (%)	8.5
Yes	Ramp Width (in)	59.0	Yes	Ramp XSlope (%)	0.9
N/A	Flare Type LT	N/A	N/A	Flare Type RT	N/A
N/A	Flare Slope LT (%)	N/A	N/A	Flare Slope RT (%)	N/A
N/A	Flare Traversable LT?	N/A	N/A	Flare Traversable RT?	N/A
N/A	Landing Length (in)	N/A	N/A	DWS Provided?	N/A
N/A	Landing Width (in)	N/A	N/A	DWS Contrast?	N/A
N/A	Landing Slope (%)	N/A	N/A	DWS Length (in)	N/A
N/A	Landing X Slope (%)	N/A	N/A	DWS Full Width?	N/A
N/A	Landing Curb? (Y/N)	N/A	N/A	DWS Offset (in)	N/A
N/A	Shared Landing?	N/A			
N/A	Gutter Ponding?	N/A	N/A	Gutter Slope (%)	N/A
N/A	Gutter Lip Ht (in)	N/A	N/A	Gutter X Slope (%)	N/A
N/A	Painted X Walk1?	No	N/A	Painted X Walk2?	N/A
	X Walk 1 Direction	To SE		X Walk 2 Direction	N/A
N/A	X Walk 1 Width (in)	N/A	N/A	X Walk 2 Width (in)	N/A
	X Walk 1 Slope (%)	1.6		X Walk 2 Slope (%)	N/A
	X Walk 1 X Slope (%)	2.9		X Walk 2 X Slope (%)	N/A

N/A	Ramp inside XWalk1?	N/A	N/A	Ramp inside XWalk2?	N/A
	Road Slope (%)	N/A	N/A	Clear Space?	N/A
	Road X Slope (%)	N/A	N/A	Clear Space to XWalk (in)	N/A
N/A	Any Obstructions?	N/A	N/A	Storm Grate/Utility Hazard?	N/A
	Obstruction Type			Storm Grate/Utility Type	
		N/A			N/A
			Yes	Surface Condition? (G/P)	Good

Remove & Replace Entire Ramp.
