Access Compliance Report

Public Rights-of-Way

(Curb Ramps)

Intersection ID: 15514	Main Street: COLDSTREAM_LN	Cross Street: N WENDOVER RD	Location: NW
ADA ID: 6E5A0D99EA60	Ramp Type: Perp	Initial Pass/Fail: Fail	Overall Compliance: No
Severity Score: 21.25			
Codes/Mitigation Info/Possible Solution		Field Measurements/Component Compliance

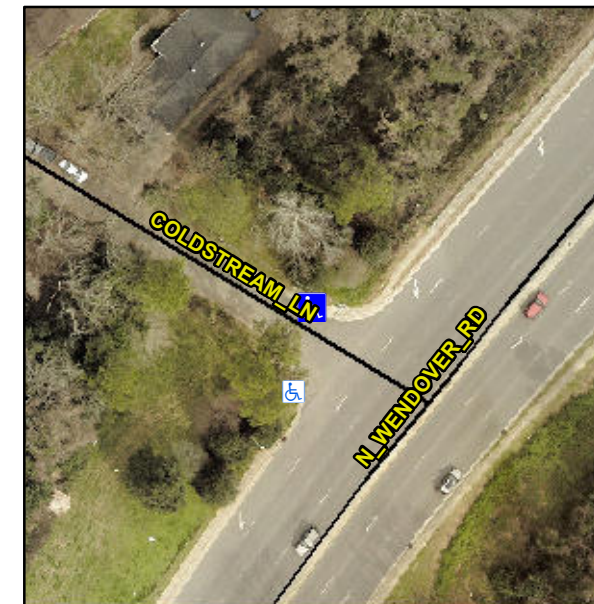
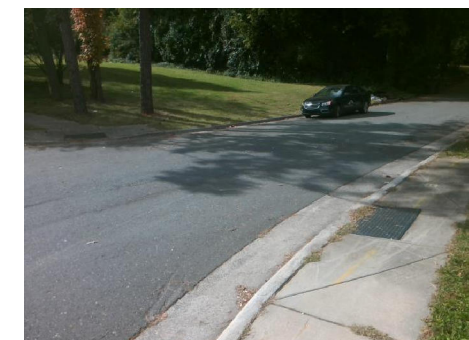
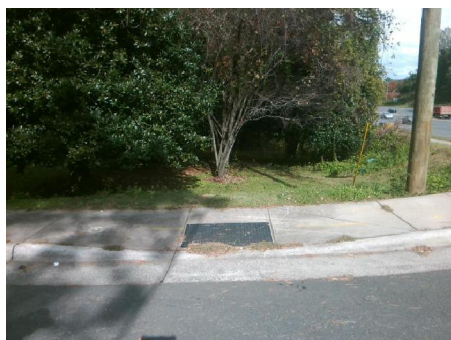
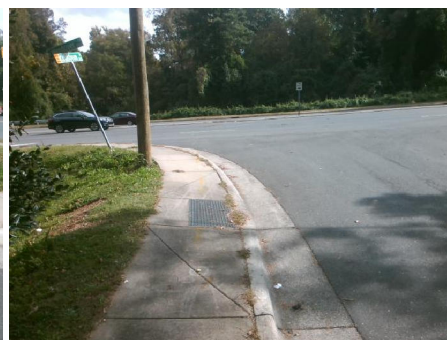
R304.5.1, R304.2.2

Compliance	Description	Data	Compliance	Description	Data
N/A	Ramp Length (in)	48.0	No	Ramp Slope (%)	10.7
No	Ramp Width (in)	47.0	Yes	Ramp XSlope (%)	2.0
N/A	Flare Type LT	N/A	N/A	Flare Type RT	N/A
N/A	Flare Slope LT (%)	N/A	N/A	Flare Slope RT (%)	N/A
N/A	Flare Traversable LT?	N/A	N/A	Flare Traversable RT?	N/A
N/A	Landing Length (in)	N/A	N/A	DWS Provided?	N/A
N/A	Landing Width (in)	N/A	N/A	DWS Contrast?	N/A
N/A	Landing Slope (%)	N/A	N/A	DWS Length (in)	N/A
N/A	Landing X Slope (%)	N/A	N/A	DWS Full Width?	N/A
N/A	Landing Curb? (Y/N)	N/A	N/A	DWS Offset (in)	N/A
N/A	Shared Landing?	N/A			
N/A	Gutter Ponding?	N/A	N/A	Gutter Slope (%)	N/A
N/A	Gutter Lip Ht (in)	N/A	N/A	Gutter X Slope (%)	N/A
N/A	Painted X Walk1?	No	N/A	Painted X Walk2?	N/A
	X Walk 1 Direction	To SW		X Walk 2 Direction	N/A
N/A	X Walk 1 Width (in)	N/A	N/A	X Walk 2 Width (in)	N/A
	X Walk 1 Slope (%)	2.3		X Walk 2 Slope (%)	N/A
	X Walk 1 X Slope (%)	2.2		X Walk 2 X Slope (%)	N/A

N/A	Ramp inside XWalk1?	N/A	N/A	Ramp inside XWalk2?	N/A
	Road Slope (%)	N/A	N/A	Clear Space?	N/A
	Road X Slope (%)	N/A	N/A	Clear Space to XWalk (in)	N/A
N/A	Any Obstructions?	N/A	N/A	Storm Grate/Utility Hazard?	N/A
	Obstruction Type			Storm Grate/Utility Type	
		N/A			N/A
			Yes	Surface Condition? (G/P)	Good

Possible Solutions:

Remove & Replace Entire Ramp.
