Access Compliance Report

Public Rights-of-Way

(Curb Ramps)

Intersection ID: 4829	Main Street: ARKLOW_RD	Cross Street: SADDLE_TRAIL_LN	Location:	N
ADA ID: 6E6367821C8A	Ramp Type: Perp	Initial Pass/Fail: Fail	Overall Compliance: No	Severity Score: 46.25
Codes/Mitigation Info/Possible Solution		Field Measurements/Component Compliance

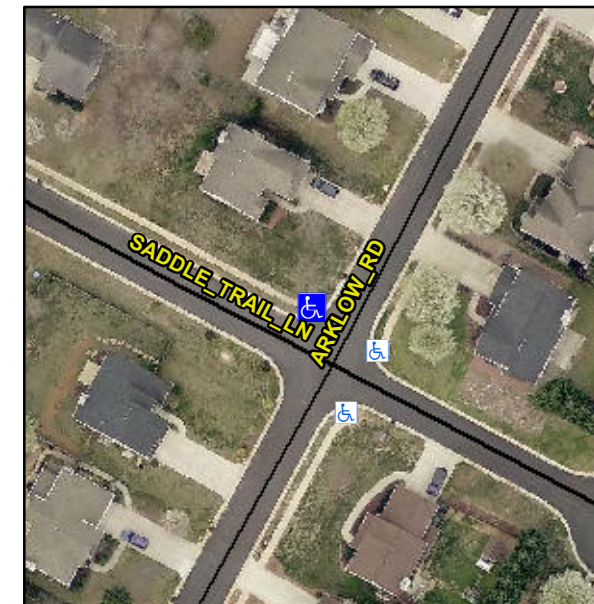
PROW/ADA:

Not Found, R304.5.1, R304.2.2, R304.5.3

Compliance	Description	Data	Compliance	Description	Data
N/A	Ramp Length (in)	48.0	No	Ramp Slope (%)	13.9
No	Ramp Width (in)	37.0	No	Ramp XSlope (%)	5.1
N/A	Flare Type LT	N/A	N/A	Flare Type RT	N/A
N/A	Flare Slope LT (%)	N/A	N/A	Flare Slope RT (%)	N/A
N/A	Flare Traversable LT?	N/A	N/A	Flare Traversable RT?	N/A
N/A	Landing Length (in)	N/A	N/A	DWS Provided?	N/A
N/A	Landing Width (in)	N/A	N/A	DWS Contrast?	N/A
N/A	Landing Slope (%)	N/A	N/A	DWS Length (in)	N/A
N/A	Landing X Slope (%)	N/A	N/A	DWS Full Width?	N/A
N/A	Landing Curb? (Y/N)	N/A	N/A	DWS Offset (in)	N/A
N/A	Shared Landing?	N/A			
N/A	Gutter Ponding?	N/A	N/A	Gutter Slope (%)	N/A
N/A	Gutter Lip Ht (in)	N/A	N/A	Gutter X Slope (%)	N/A
N/A	Painted X Walk1?	No	N/A	Painted X Walk2?	N/A
	X Walk 1 Direction	To SE		X Walk 2 Direction	N/A
N/A	X Walk 1 Width (in)	N/A	N/A	X Walk 2 Width (in)	N/A
	X Walk 1 Slope (%)	3.0		X Walk 2 Slope (%)	N/A
	X Walk 1 X Slope (%)	5.7		X Walk 2 X Slope (%)	N/A

N/A	Ramp inside XWalk1?	N/A	N/A	Ramp inside XWalk2?	N/A
	Road Slope (%)	N/A	N/A	Clear Space?	N/A
	Road X Slope (%)	N/A	N/A	Clear Space to XWalk (in)	N/A
N/A	Any Obstructions?	N/A	N/A	Storm Grate/Utility Hazard?	N/A
	Obstruction Type			Storm Grate/Utility Type	
		N/A			N/A
			Yes	Surface Condition? (G/P)	Good

Possible Solutions:

Remove & Replace Entire Ramp.
