Access Compliance Report

Public Rights-of-Way (Curb Ramps)

Intersection ID: 17141	Main Street: PARK_RD	Cross Street: WYNDCROFTE_PL	Location: SE
ADA ID: 6E68B7AAD4CB	Ramp Type: PerpDiag	Initial Pass/Fail: Fail	Overall Compliance: No
		Severity Score: 31.25

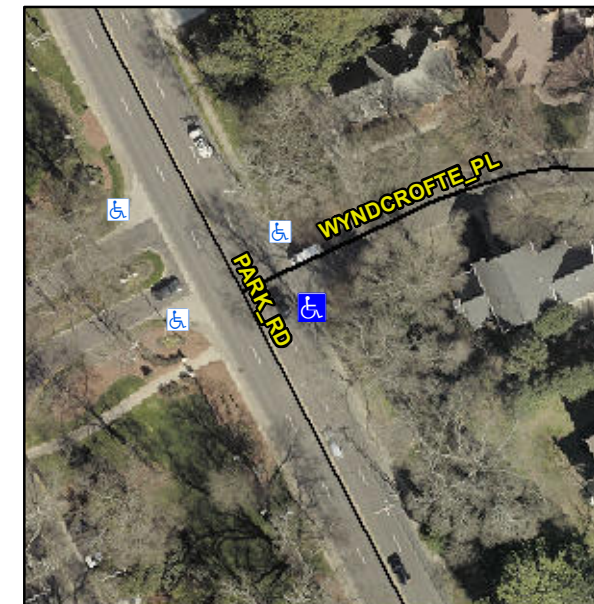
Compliance	Description	Data	Compliance	Description	Data
N/A	Ramp Length (in)	60.0	No	Ramp Slope (%)	10.3
No	Ramp Width (in)	33.0	No	Ramp XSlope (%)	3.3
N/A	Flare Type LT	N/A	N/A	Flare Type RT	N/A
N/A	Flare Slope LT (%)	N/A	N/A	Flare Slope RT (%)	N/A
N/A	Flare Traversable LT?	N/A	N/A	Flare Traversable RT?	N/A
N/A	Landing Length (in)	N/A	N/A	DWS Provided?	N/A
N/A	Landing Width (in)	N/A	N/A	DWS Contrast?	N/A
N/A	Landing Slope (%)	N/A	N/A	DWS Length (in)	N/A
N/A	Landing X Slope (%)	N/A	N/A	DWS Full Width?	N/A
N/A	Landing Curb? (Y/N)	N/A	N/A	DWS Offset (in)	N/A
N/A	Shared Landing?	N/A			
N/A	Gutter Ponding?	N/A	N/A	Gutter Slope (%)	N/A
N/A	Gutter Lip Ht (in)	N/A	N/A	Gutter X Slope (%)	N/A
N/A	Painted X Walk1?	No	N/A	Painted X Walk2?	No
	X Walk 1 Direction	To NW		X Walk 2 Direction	To NW
N/A	X Walk 1 Width (in)	N/A	N/A	X Walk 2 Width (in)	N/A
	X Walk 1 Slope (%)	1.0		X Walk 2 Slope (%)	3.6
	X Walk 1 X Slope (%)	2.7		X Walk 2 X Slope (%)	4.7

N/A	Ramp inside XWalk1?	N/A	N/A	Ramp inside XWalk2?	N/A
	Road Slope (%)	4.0	N/A	Clear Space?	N/A
	Road X Slope (%)	5.0	N/A	Clear Space to XWalk (in)	N/A
N/A	Any Obstructions?	N/A	N/A	Storm Grate/Utility Hazard?	N/A
	Obstruction Type			Storm Grate/Utility Type	
		N/A			N/A
			Yes	Surface Condition? (G/P)	Good

Possible Solutions:

Remove & Replace Curb Ramp With Two New Directional Ramps or Equivalent.

R304.5.1, R304.2.2, R304.5.3
