# Access Compliance Report

## Public Rights-of-Way

### (Curb Ramps)

Intersection ID: 49931	Main Street: WOBURN_RD	Cross Street: ASHBOURNE_HALL_RD	Location: SE
ADA ID: 6E69F0D9AE0B	Ramp Type: Perp	Initial Pass/Fail: Fail	Overall Compliance: No
Severity Score: 13.75			
Codes/Mitigation Info/Possible Solution		Field Measurements/Component Compliance

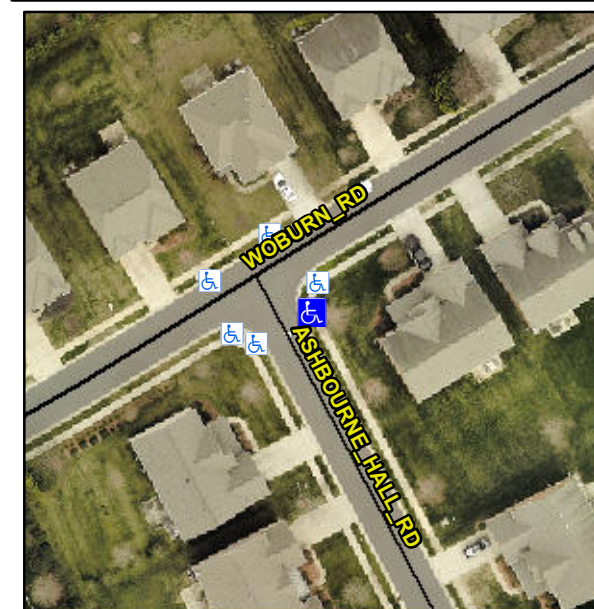
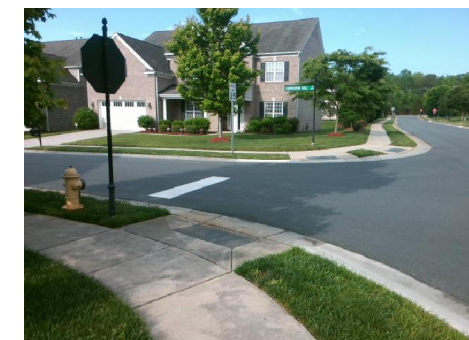
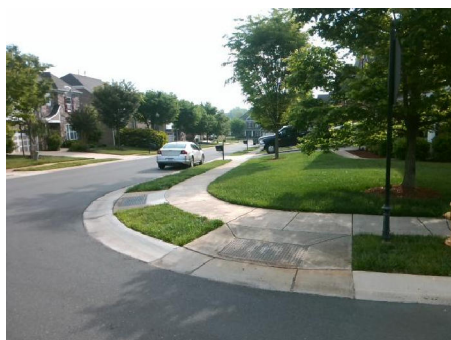
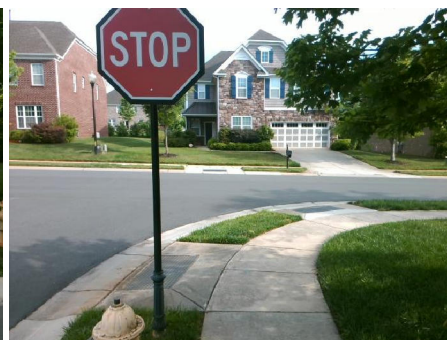
**Not Found, R304.2.2, R304.5.3**

Compliance	Description	Data	Compliance	Description	Data
N/A	Ramp Length (in)	50.0	No	Ramp Slope (%)	9.3
Yes	Ramp Width (in)	48.0	No	Ramp XSlope (%)	2.2
N/A	Flare Type LT	N/A	N/A	Flare Type RT	N/A
N/A	Flare Slope LT (%)	N/A	N/A	Flare Slope RT (%)	N/A
N/A	Flare Traversable LT?	N/A	N/A	Flare Traversable RT?	N/A
N/A	Landing Length (in)	N/A	N/A	DWS Provided?	N/A
N/A	Landing Width (in)	N/A	N/A	DWS Contrast?	N/A
N/A	Landing Slope (%)	N/A	N/A	DWS Length (in)	N/A
N/A	Landing X Slope (%)	N/A	N/A	DWS Full Width?	N/A
N/A	Landing Curb? (Y/N)	N/A	N/A	DWS Offset (in)	N/A
N/A	Shared Landing?	N/A			
N/A	Gutter Ponding?	N/A	N/A	Gutter Slope (%)	N/A
N/A	Gutter Lip Ht (in)	N/A	N/A	Gutter X Slope (%)	N/A
N/A	Painted X Walk1?	No	N/A	Painted X Walk2?	N/A
	X Walk 1 Direction	To SW		X Walk 2 Direction	N/A
N/A	X Walk 1 Width (in)	N/A	N/A	X Walk 2 Width (in)	N/A
	X Walk 1 Slope (%)	2.9		X Walk 2 Slope (%)	N/A
	X Walk 1 X Slope (%)	0.5		X Walk 2 X Slope (%)	N/A

N/A	Ramp inside XWalk1?	N/A	N/A	Ramp inside XWalk2?	N/A
	Road Slope (%)	N/A	N/A	Clear Space?	N/A
	Road X Slope (%)	N/A	N/A	Clear Space to XWalk (in)	N/A
N/A	Any Obstructions?	N/A	N/A	Storm Grate/Utility Hazard?	N/A
	Obstruction Type			Storm Grate/Utility Type	
		N/A			N/A
		Yes		Surface Condition? (G/P)	Good

**Remove & Replace Entire Ramp.**
