Access Compliance Report

Public Rights-of-Way

(Curb Ramps)

Intersection ID: 26134	Main Street: NUTHATCH_CT	Cross Street: SANDPIPER DR	Location:	N
ADA ID: 6E6B10279CFB	Ramp Type: PerpDiag	Initial Pass/Fail: Fail	Overall Compliance: No	Severity Score: 21.25
Codes/Mitigation Info/Possible Solution		Field Measurements/Component Compliance

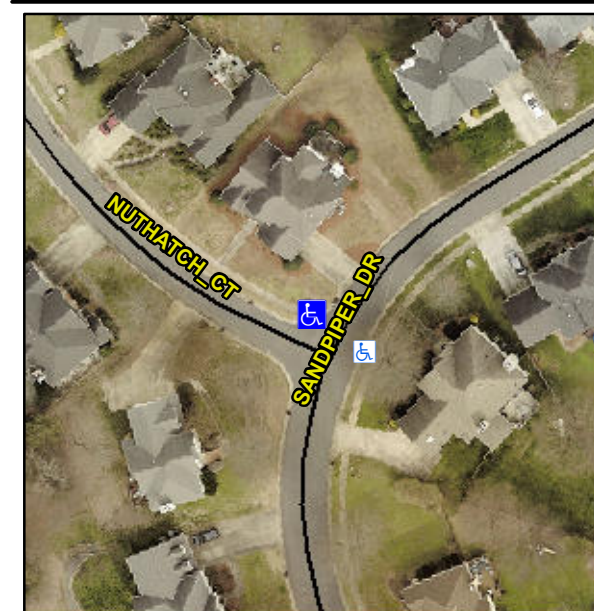
Not Found, R304.5.1, R304.5.3

Compliance	Description	Data	Compliance	Description	Data
N/A	Ramp Length (in)	98.0	Yes	Ramp Slope (%)	7.3
No	Ramp Width (in)	40.5	No	Ramp XSlope (%)	6.6
N/A	Flare Type LT	N/A	N/A	Flare Type RT	N/A
N/A	Flare Slope LT (%)	N/A	N/A	Flare Slope RT (%)	N/A
N/A	Flare Traversable LT?	N/A	N/A	Flare Traversable RT?	N/A
N/A	Landing Length (in)	N/A	N/A	DWS Provided?	N/A
N/A	Landing Width (in)	N/A	N/A	DWS Contrast?	N/A
N/A	Landing Slope (%)	N/A	N/A	DWS Length (in)	N/A
N/A	Landing X Slope (%)	N/A	N/A	DWS Full Width?	N/A
N/A	Landing Curb? (Y/N)	N/A	N/A	DWS Offset (in)	N/A
N/A	Shared Landing?	N/A			
N/A	Gutter Ponding?	N/A	N/A	Gutter Slope (%)	N/A
N/A	Gutter Lip Ht (in)	N/A	N/A	Gutter X Slope (%)	N/A
N/A	Painted X Walk1?	No	N/A	Painted X Walk2?	No
	X Walk 1 Direction	To SW		X Walk 2 Direction	To SE
N/A	X Walk 1 Width (in)	N/A	N/A	X Walk 2 Width (in)	N/A
	X Walk 1 Slope (%)	0.3		X Walk 2 Slope (%)	2.0
	X Walk 1 X Slope (%)	3.7		X Walk 2 X Slope (%)	1.0

N/A	Ramp inside XWalk1?	N/A	N/A	Ramp inside XWalk2?	N/A
	Road Slope (%)	2.8	N/A	Clear Space?	N/A
	Road X Slope (%)	1.8	N/A	Clear Space to XWalk (in)	N/A
N/A	Any Obstructions?	N/A	N/A	Storm Grate/Utility Hazard?	N/A
	Obstruction Type			Storm Grate/Utility Type	
		N/A			N/A
			Yes	Surface Condition? (G/P)	Good

Remove & Replace Curb Ramp With Two New Directional Ramps or Equivalent.
