# Access Compliance Report

## Public Rights-of-Way

### (Curb Ramps)

| Intersection ID: 23808 | Main Street: LONGLEAF_DR | Cross Street: N/A | Location: SW |

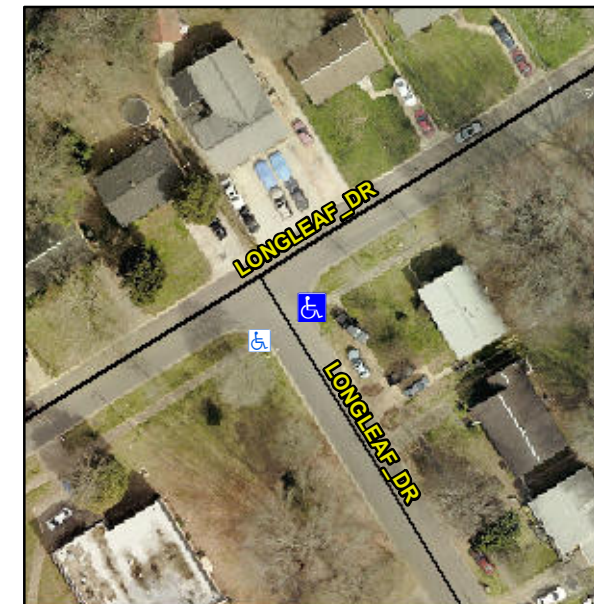
| ADA ID: 6E6F46685BF0 | Ramp Type: PerpDiag | Initial Pass/Fail: Fail | Overall Compliance: No |

**Not Found, R304.5.3**

| Compliance | Description | Data | Compliance | Description | Data |
|---|---|---|---|---|---|
| Yes | Ramp Width (in) | 56.0 | No | Ramp XSlope (%) | 8.9 |

**Remove & Replace Curb Ramp With Two New Directional Ramps or Equivalent.**
