Access Compliance Report

Public Rights-of-Way

(Curb Ramps)

Intersection ID: 8948	Main Street: FLAT_ROCK_DR	Cross Street: LITTLE_ROCK_RD	Location: S
ADA ID: 6E714E0AB941	Ramp Type: Perp	Initial Pass/Fail: Fail	Overall Compliance: No
			Severity Score: 21.25

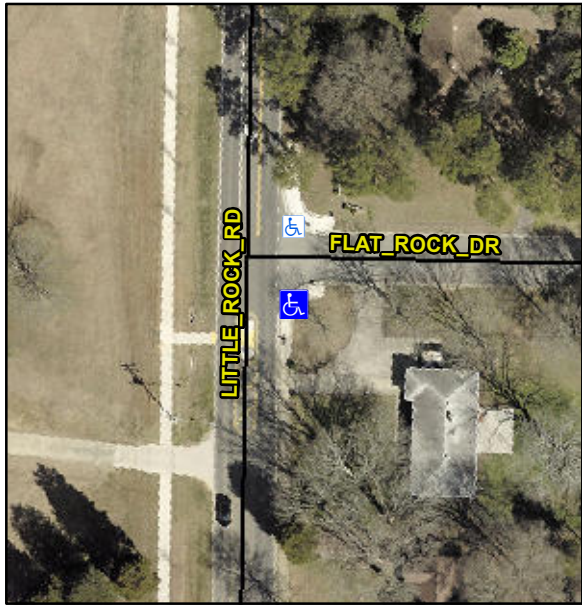
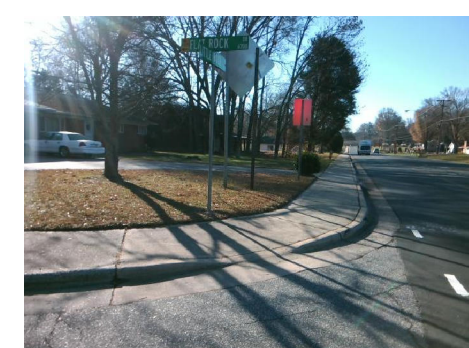
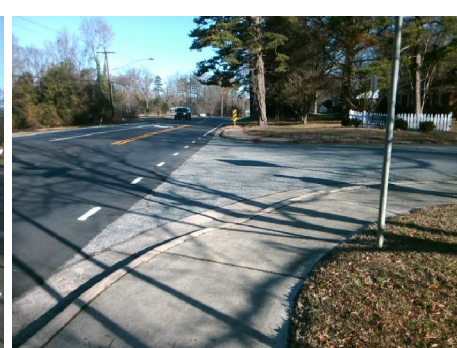
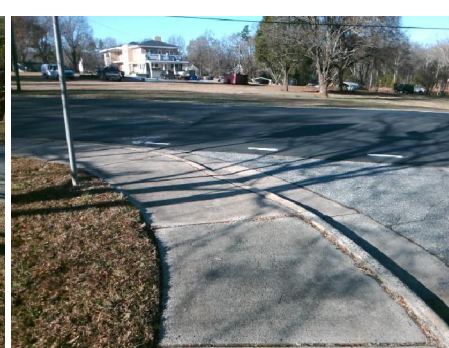
Possible Solutions:		Compliance	Description	Data	Compliance	Description	Data
	Remove & Replace Entire Ramp.		N/A	Ramp Length (in)	60.0	No	Ramp Slope (%)	8.8
			No	Ramp Width (in)	36.0	Yes	Ramp XSlope (%)	1.4
			N/A	Flare Type LT	N/A	N/A	Flare Type RT	N/A
			N/A	Flare Slope LT (%)	N/A	N/A	Flare Slope RT (%)	N/A
			N/A	Flare Traversable LT?	N/A	N/A	Flare Traversable RT?	N/A
			N/A	Landing Length (in)	N/A	N/A	DWS Provided?	N/A
			N/A	Landing Width (in)	N/A	N/A	DWS Contrast?	N/A
			N/A	Landing Slope (%)	N/A	N/A	DWS Length (in)	N/A
			N/A	Landing X Slope (%)	N/A	N/A	DWS Full Width?	N/A
Surveyor Notes:	N/A		N/A	Landing Curb? (Y/N)	N/A	N/A	DWS Offset (in)	N/A
			N/A	Shared Landing?	N/A			
	PROW/ADA:		N/A	Gutter Ponding?	N/A	N/A	Gutter Slope (%)	N/A
	Not Found, R304.5.1, R304.2.2		N/A	Gutter Lip Ht (in)	N/A	N/A	Gutter X Slope (%)	N/A

N/A	Painted X Walk1?	No	N/A	Painted X Walk2?	N/A
				X Walk 1 Direction	To N		X Walk 2 Direction	N/A
			N/A	X Walk 1 Width (in)	N/A	N/A	X Walk 2 Width (in)	N/A
				X Walk 1 Slope (%)	1.2		X Walk 2 Slope (%)	N/A
				X Walk 1 X Slope (%)	0.5		X Walk 2 X Slope (%)	N/A
			N/A	Ramp inside XWalk1?	N/A	N/A	Ramp inside XWalk2?	N/A
Total Cost:				Road Slope (%)	N/A	N/A	Clear Space?	N/A
				Road X Slope (%)	N/A	N/A	Clear Space to XWalk (in)	N/A
			N/A	Any Obstructions?	N/A	N/A	Storm Grate/Utility Hazard?	N/A
				Obstruction Type			Storm Grate/Utility Type	
						N/A		N/A
						Yes	Surface Condition? (G/P)	Good
