Intersection ID: 10032537	Main Street: N_COLLEGE_ST	Cross Street: N/A	Location:	S
ADA ID: 6E7FF6E97736	Ramp Type: Perp	Initial Pass/Fail: Fail	Overall Compliance: No	Severity Score: 10

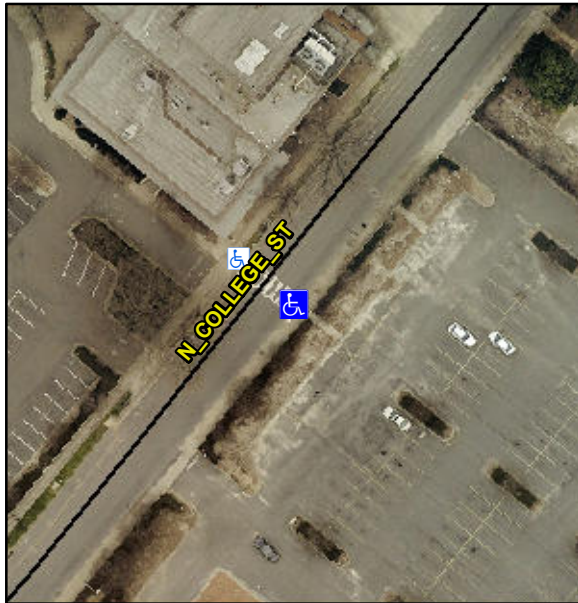
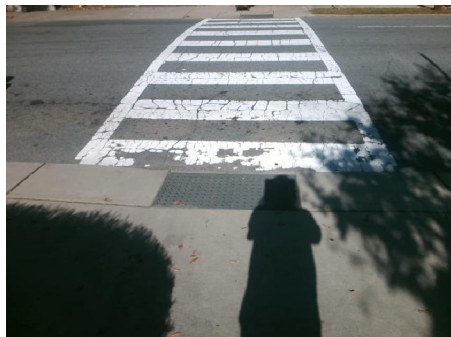
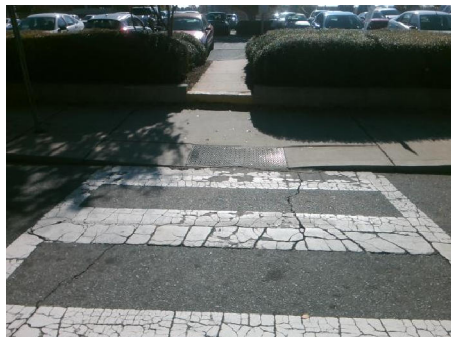
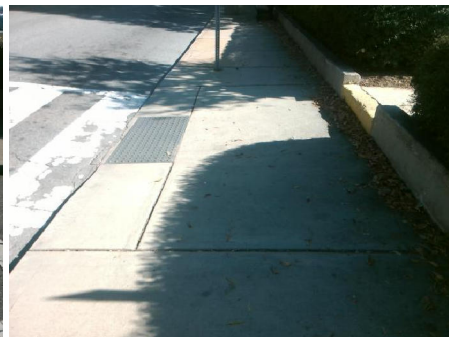
R304.5.1, R304.5.3

Compliance	Description	Data	Compliance	Description	Data
N/A	Ramp Length (in)	100.0	Yes	Ramp Slope (%)	5.9
No	Ramp Width (in)	47.5	No	Ramp XSlope (%)	3.3
N/A	Flare Type LT	N/A	N/A	Flare Type RT	N/A
N/A	Flare Slope LT (%)	N/A	N/A	Flare Slope RT (%)	N/A
N/A	Flare Traversable LT?	N/A	N/A	Flare Traversable RT?	N/A
N/A	Landing Length (in)	N/A	N/A	DWS Provided?	N/A
N/A	Landing Width (in)	N/A	N/A	DWS Contrast?	N/A
N/A	Landing Slope (%)	N/A	N/A	DWS Length (in)	N/A
N/A	Landing X Slope (%)	N/A	N/A	DWS Full Width?	N/A
N/A	Landing Curb? (Y/N)	N/A	N/A	DWS Offset (in)	N/A
N/A	Shared Landing?	N/A			
N/A	Gutter Ponding?	N/A	N/A	Gutter Slope (%)	N/A
N/A	Gutter Lip Ht (in)	N/A	N/A	Gutter X Slope (%)	N/A
N/A	Painted X Walk1?	Yes	N/A	Painted X Walk2?	N/A
	X Walk 1 Direction	To NW		X Walk 2 Direction	N/A
N/A	X Walk 1 Width (in)	113.0	N/A	X Walk 2 Width (in)	N/A
	X Walk 1 Slope (%)	6.4		X Walk 2 Slope (%)	N/A
	X Walk 1 X Slope (%)	1.6		X Walk 2 X Slope (%)	N/A

N/A	Ramp inside XWalk1?	Yes	N/A	Ramp inside XWalk2?	N/A
	Road Slope (%)	N/A	N/A	Clear Space?	N/A
	Road X Slope (%)	N/A	N/A	Clear Space to XWalk (in)	N/A
N/A	Any Obstructions?	N/A	N/A	Storm Grate/Utility Hazard?	N/A
	Obstruction Type			Storm Grate/Utility Type	
		N/A			N/A
			Yes	Surface Condition? (G/P)	Good

Remove & Replace Entire Ramp.
