Access Compliance Report

Public Rights-of-Way

(Curb Ramps)

Intersection ID: N/A	Main Street: NOBLES_AV	Cross Street: N/A	Location: SE
ADA ID: 6E87CB8178BE	Ramp Type: Perp	Initial Pass/Fail: Fail	Overall Compliance: No
		Severity Score: 12.5

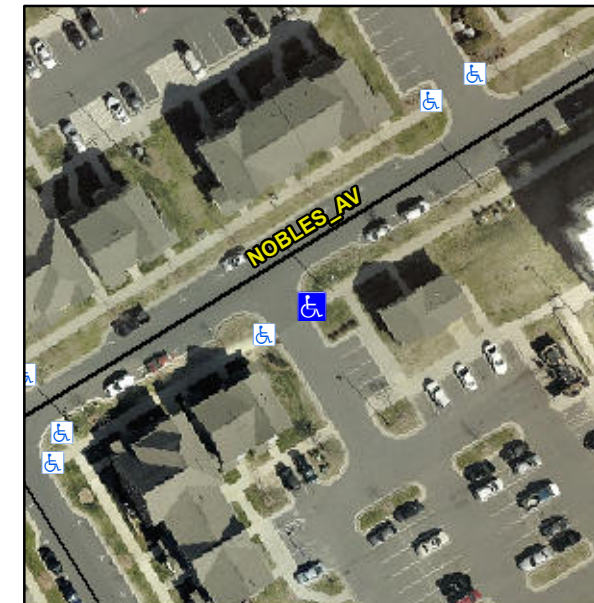
Not Found, R304.2.2

Compliance	Description	Data	Compliance	Description	Data
N/A	Ramp Length (in)	72.0	No	Ramp Slope (%)	10.7
Yes	Ramp Width (in)	70.0	Yes	Ramp XSlope (%)	1.6
N/A	Flare Type LT	N/A	N/A	Flare Type RT	N/A
N/A	Flare Slope LT (%)	N/A	N/A	Flare Slope RT (%)	N/A
N/A	Flare Traversable LT?	N/A	N/A	Flare Traversable RT?	N/A
N/A	Landing Length (in)	N/A	N/A	DWS Provided?	N/A
N/A	Landing Width (in)	N/A	N/A	DWS Contrast?	N/A
N/A	Landing Slope (%)	N/A	N/A	DWS Length (in)	N/A
N/A	Landing X Slope (%)	N/A	N/A	DWS Full Width?	N/A
N/A	Landing Curb? (Y/N)	N/A	N/A	DWS Offset (in)	N/A
N/A	Shared Landing?	N/A			
N/A	Gutter Ponding?	N/A	N/A	Gutter Slope (%)	N/A
N/A	Gutter Lip Ht (in)	N/A	N/A	Gutter X Slope (%)	N/A
N/A	Painted X Walk1?	No	N/A	Painted X Walk2?	N/A
	X Walk 1 Direction	To W		X Walk 2 Direction	N/A
N/A	X Walk 1 Width (in)	N/A	N/A	X Walk 2 Width (in)	N/A
	X Walk 1 Slope (%)	3.7		X Walk 2 Slope (%)	N/A
	X Walk 1 X Slope (%)	1.6		X Walk 2 X Slope (%)	N/A

Remove & Replace Entire Ramp.
