Access Compliance Report

Public Rights-of-Way

(Curb Ramps)

Intersection ID: N/A	Main Street: VILLAGE_WALK_RD	Cross Street: HOUSTON_FIELD_CT	Location: SW
ADA ID: 6E8810EB5293	Ramp Type: Perp	Initial Pass/Fail: Fail	Overall Compliance: No
Codes/Mitigation Info/Possible Solution		Field Measurements/Component Compliance	
Severity Score: 13.75

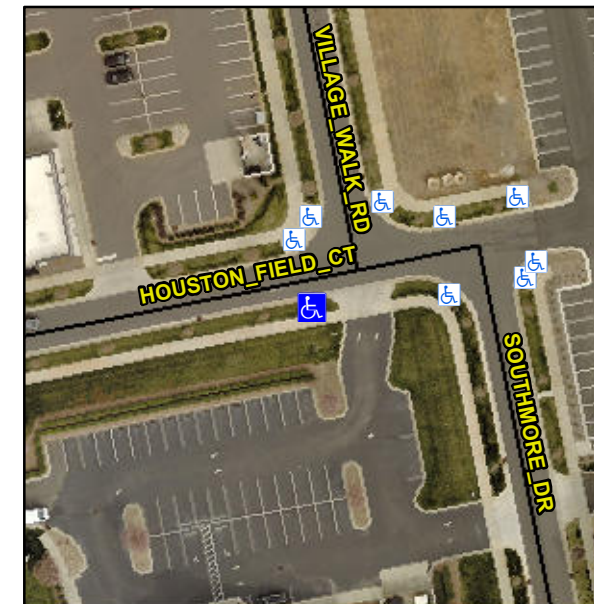
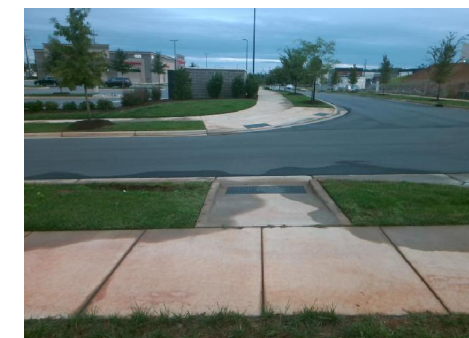
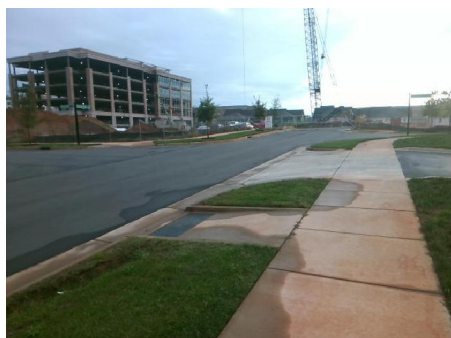
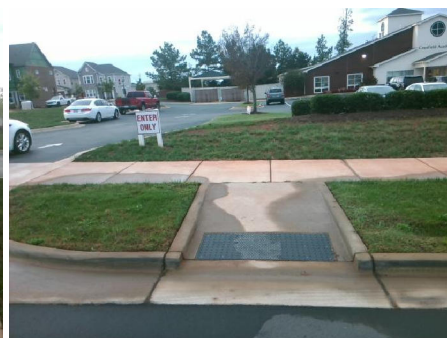
Not Found, R304.2.2

Compliance	Description	Data	Compliance	Description	Data
N/A	Ramp Length (in)	96.0	No	Ramp Slope (%)	8.8
Yes	Ramp Width (in)	70.0	Yes	Ramp XSlope (%)	2.6
N/A	Flare Type LT	N/A	N/A	Flare Type RT	N/A
N/A	Flare Slope LT (%)	N/A	N/A	Flare Slope RT (%)	N/A
N/A	Flare Traversable LT?	N/A	N/A	Flare Traversable RT?	N/A
N/A	Landing Length (in)	N/A	N/A	DWS Provided?	N/A
N/A	Landing Width (in)	N/A	N/A	DWS Contrast?	N/A
N/A	Landing Slope (%)	N/A	N/A	DWS Length (in)	N/A
N/A	Landing X Slope (%)	N/A	N/A	DWS Full Width?	N/A
N/A	Landing Curb? (Y/N)	N/A	N/A	DWS Offset (in)	N/A
N/A	Shared Landing?	N/A			
N/A	Gutter Ponding?	N/A	N/A	Gutter Slope (%)	N/A
N/A	Gutter Lip Ht (in)	N/A	N/A	Gutter X Slope (%)	N/A
N/A	Painted X Walk1?	No	N/A	Painted X Walk2?	N/A
	X Walk 1 Direction	To N		X Walk 2 Direction	N/A
N/A	X Walk 1 Width (in)	N/A	N/A	X Walk 2 Width (in)	N/A
	X Walk 1 Slope (%)	3.4		X Walk 2 Slope (%)	N/A
	X Walk 1 X Slope (%)	4.6		X Walk 2 X Slope (%)	N/A

N/A	Ramp inside XWalk1?	N/A	N/A	Ramp inside XWalk2?	N/A
	Road Slope (%)	N/A	N/A	Clear Space?	N/A
	Road X Slope (%)	N/A	N/A	Clear Space to XWalk (in)	N/A
N/A	Any Obstructions?	N/A	N/A	Storm Grate/Utility Hazard?	N/A
	Obstruction Type			Storm Grate/Utility Type	
		N/A			N/A
			Yes	Surface Condition? (G/P)	Good

Remove & Replace Entire Ramp.
