Access Compliance Report Public Rights-of-Way (Curb Ramps)

Intersection ID: 30634 Main Street: HADDONFIELD PL **Cross Street: TOM SHORT RD** Location: SW ADA ID: 6E8822C6EFE2 Ramp Type: PerpDiag Initial Pass/Fail: Fail **Overall Compliance: No Severity Score:** 22.5

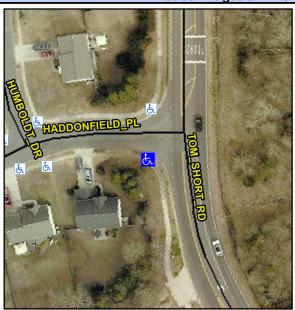
Field Measuren	nents/Co Data				
		Compliance Description				Description	Data
	N/A	Ramp Length (in)	46.0	No		Slope (%)	11.8
	No	Ramp Width (in)	47.0	No		XSlope (%)	3.0
	N/A	Flare Type LT	N/A	N/A	Flare	Type RT	N/A
	N/A	Flare Slope LT (%)	N/A	N/A	Flare	Slope RT (%)	N/A
	N/A	Flare Traversable LT?	N/A	N/A	Flare	Traversable RT?	N/A
	N/A	Landing Length (in)	N/A	N/A	DWS	Provided?	N/A
	N/A	Landing Width (in)	N/A	N/A	DWS	Contrast?	N/A
	N/A	Landing Slope (%)	N/A	N/A	DWS	Length (in)	N/A
	N/A	Landing X Slope (%)	N/A	N/A	DWS	Full Width?	N/A
	N/A	Landing Curb? (Y/N)	N/A	N/A	DWS	Offset (in)	N/A
	N/A	Shared Landing?	N/A				
	N/A	Gutter Ponding?	N/A	N/A	Gutte	er Slope (%)	N/A
	N/A	Gutter Lip Ht (in)	N/A	N/A	Gutte	er X Slope (%)	N/A
	N/A	Painted X Walk1?	No	N/A	Paint	ed X Walk2?	No
		X Walk 1 Direction	То Е		X Wa	lk 2 Direction	To N
	N/A	X Walk 1 Width (in)	N/A	N/A	X Wa	lk 2 Width (in)	N/A
		X Walk 1 Slope (%)	3.6		X Wa	lk 2 Slope (%)	0.7

X Walk 1 X Slope (%)	2.4		X Wa	lk 2 X Slope (%)	3.4
	N/A	Ramp inside XWalk1?	N/A	N/A	Ram	o inside XWalk2?	N/A
		Road Slope (%)	3.1	N/A	Clear	Space?	N/A
		Road X Slope (%)	0.8	N/A	Clear	Space to XWalk (in)	N/A
	N/A	Any Obstructions?	N/A	N/A	Storn	n Grate/Utility Hazard?	N/A
		Obstruction Type			Storn	n Grate/Utility Type	
			N/A				N/A
				Yes	Surfa	ce Condition? (G/P)	Good
1				•		, ,

Possible Solutions: Remove & Replace Curb Ramp With Two New Directional Ramps or Equivalent. Surveyor Notes: N/A PROW/ADA: R304.5.1, R304.2.2, R304.5.3
