Access Compliance Report

Public Rights-of-Way

(Curb Ramps)

Intersection ID: 14501	Main Street: BALDWIN_AV	Cross Street: ELLISON_ST	Location: SW
ADA ID: 6E8B30485EC1	Ramp Type: PerpDiag	Initial Pass/Fail: Fail	Overall Compliance: No
Severity Score: 21.25			
Codes/Mitigation Info/Possible Solution		Field Measurements/Component Compliance

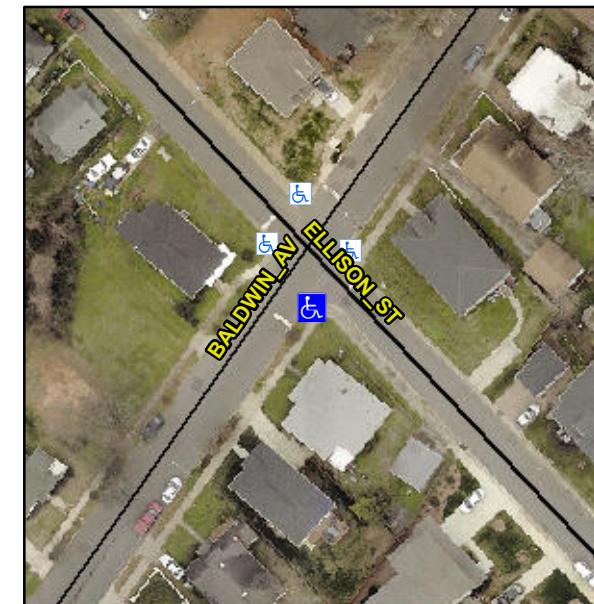
Not Found, R304.5.1, R304.2.2

Compliance	Description	Data	Compliance	Description	Data
N/A	Ramp Length (in)	62.0	No	Ramp Slope (%)	10.5
No	Ramp Width (in)	37.0	Yes	Ramp XSlope (%)	0.8
N/A	Flare Type LT	N/A	N/A	Flare Type RT	N/A
N/A	Flare Slope LT (%)	N/A	N/A	Flare Slope RT (%)	N/A
N/A	Flare Traversable LT?	N/A	N/A	Flare Traversable RT?	N/A
N/A	Landing Length (in)	N/A	N/A	DWS Provided?	N/A
N/A	Landing Width (in)	N/A	N/A	DWS Contrast?	N/A
N/A	Landing Slope (%)	N/A	N/A	DWS Length (in)	N/A
N/A	Landing X Slope (%)	N/A	N/A	DWS Full Width?	N/A
N/A	Landing Curb? (Y/N)	N/A	N/A	DWS Offset (in)	N/A
N/A	Shared Landing?	N/A			
N/A	Gutter Ponding?	N/A	N/A	Gutter Slope (%)	N/A
N/A	Gutter Lip Ht (in)	N/A	N/A	Gutter X Slope (%)	N/A
N/A	Painted X Walk1?	No	N/A	Painted X Walk2?	No
	X Walk 1 Direction	To NE		X Walk 2 Direction	To NW
N/A	X Walk 1 Width (in)	N/A	N/A	X Walk 2 Width (in)	N/A
	X Walk 1 Slope (%)	6.5		X Walk 2 Slope (%)	4.1
	X Walk 1 X Slope (%)	3.5		X Walk 2 X Slope (%)	2.6

N/A	Ramp inside XWalk1?	N/A	N/A	Ramp inside XWalk2?	N/A
	Road Slope (%)	0.9	N/A	Clear Space?	N/A
	Road X Slope (%)	7.8	N/A	Clear Space to XWalk (in)	N/A
N/A	Any Obstructions?	N/A	N/A	Storm Grate/Utility Hazard?	N/A
	Obstruction Type			Storm Grate/Utility Type	
		N/A			N/A
		Yes		Surface Condition? (G/P)	Good

Remove & Replace Curb Ramp With Two New Directional Ramps or Equivalent.
