# Access Compliance Report

## Public Rights-of-Way

### (Curb Ramps)

Intersection ID: 10040250	Main Street: VAIL_AV	Cross Street: N/A	Location: E
ADA ID: 6E9C83B85156	Ramp Type: Directional1	Initial Pass/Fail: Fail	Overall Compliance: No
		Severity Score: 12.5

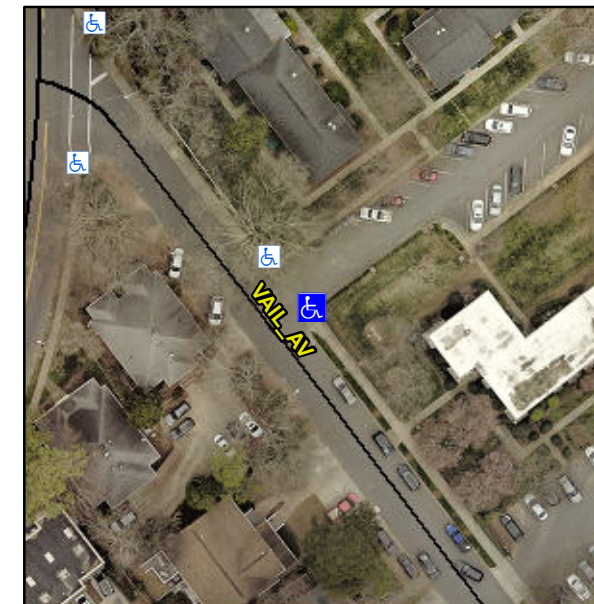
Compliance	Description	Data	Compliance	Description	Data
N/A	Ramp Length (in)	91.0	N/A	Grade Break?	N/A
Yes	Ramp Width (in)	60.0	N/A	Grade Break Slope (%)	0.0
Yes	Ramp Slope (%)	6.1	N/A	Grade Break XSlope (%)	0.0
No	Ramp XSlope (%)	5.8			
N/A	Flare Type LT	N/A	N/A	Flare Type RT	N/A
N/A	Flare Slope LT (%)	N/A	N/A	Flare Slope RT (%)	0.0
N/A	Flare Traversable LT?	N/A	N/A	Flare Traversable RT?	N/A
N/A	Landing Length (in)	0.0	N/A	DWS Provided?	N/A
N/A	Landing Width (in)	0.0	N/A	DWS Contrast?	N/A
N/A	Landing Slope (%)	0.0	N/A	DWS Length (in)	N/A
N/A	Landing X Slope (%)	0.0	N/A	DWS Full Width?	N/A
N/A	Landing Curb? (Y/N)	N/A	N/A	DWS Offset LT (in)	N/A
N/A	Shared Landing?	N/A	N/A	DWS Offset RT (in)	N/A
N/A	Gutter Ponding?	0.0	N/A	Gutter Slope (%)	N/A
N/A	Gutter Lip Ht (in)	0.0	N/A	Gutter X Slope (%)	N/A
N/A	Painted X Walk1?	No		Road Slope (%)	7.5
	X Walk 1 Direction	To NW		Road X Slope (%)	2.1
	X Walk 1 Width (in)	N/A		Clear Space?	N/A

X Walk 1 Slope (%)	7.5	N/A	Clear Space to XWalk (in)	N/A
	X Walk 1 X Slope (%)	2.1	N/A	Storm Grate/Utility Hazard?	N/A
N/A	Ramp inside XWalk1?	N/A		Storm Grate/Utility Type	
N/A	Any Obstructions?	N/A			N/A
	Obstruction Type		Yes	Surface Condition? (G/P)	Good
			N/A	Curb Slope (%)	7.4

Possible Solutions:

**Remove & Replace Entire Ramp.**

**R304.5.3**
