Access Compliance Report

Public Rights-of-Way

(Curb Ramps)

Intersection ID: N/A	Main Street: CANTERBURY CASTLE DR	Cross Street: SAGMORE HILL DR	Location: SW
ADA ID: 6E9D34EA786B	Ramp Type: Perp	Initial Pass/Fail: Fail	Overall Compliance: No
Severity Score: 8.75			
Codes/Mitigation Info/Possible Solution		Field Measurements/Component Compliance

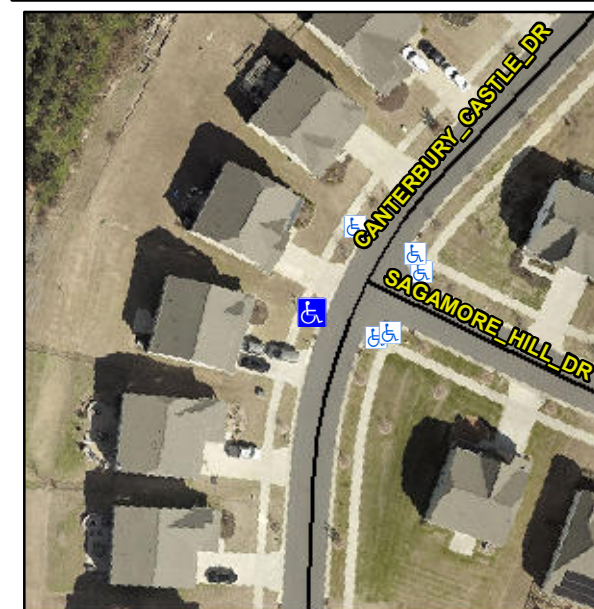
Not Found, R304.5.1

Compliance	Description	Data	Compliance	Description	Data
N/A	Ramp Length (in)	94.0	Yes	Ramp Slope (%)	6.2
No	Ramp Width (in)	46.5	Yes	Ramp XSlope (%)	1.2
N/A	Flare Type LT	N/A	N/A	Flare Type RT	N/A
N/A	Flare Slope LT (%)	N/A	N/A	Flare Slope RT (%)	N/A
N/A	Flare Traversable LT?	N/A	N/A	Flare Traversable RT?	N/A
N/A	Landing Length (in)	N/A	N/A	DWS Provided?	N/A
N/A	Landing Width (in)	N/A	N/A	DWS Contrast?	N/A
N/A	Landing Slope (%)	N/A	N/A	DWS Length (in)	N/A
N/A	Landing X Slope (%)	N/A	N/A	DWS Full Width?	N/A
N/A	Landing Curb? (Y/N)	N/A	N/A	DWS Offset (in)	N/A
N/A	Shared Landing?	N/A			
N/A	Gutter Ponding?	N/A	N/A	Gutter Slope (%)	N/A
N/A	Gutter Lip Ht (in)	N/A	N/A	Gutter X Slope (%)	N/A
N/A	Painted X Walk1?	No	N/A	Painted X Walk2?	N/A
	X Walk 1 Direction	To SE		X Walk 2 Direction	N/A
N/A	X Walk 1 Width (in)	N/A	N/A	X Walk 2 Width (in)	N/A
	X Walk 1 Slope (%)	3.1		X Walk 2 Slope (%)	N/A
	X Walk 1 X Slope (%)	0.3		X Walk 2 X Slope (%)	N/A

N/A	Ramp inside XWalk1?	N/A	N/A	Ramp inside XWalk2?	N/A
	Road Slope (%)	N/A	N/A	Clear Space?	N/A
	Road X Slope (%)	N/A	N/A	Clear Space to XWalk (in)	N/A
N/A	Any Obstructions?	N/A	N/A	Storm Grate/Utility Hazard?	N/A
	Obstruction Type			Storm Grate/Utility Type	
		N/A			N/A
		Yes		Surface Condition? (G/P)	Good

Remove & Replace Entire Ramp.
