Access Compliance Report

Public Rights-of-Way

(Curb Ramps)

Intersection ID: 10019201	Main Street: WINTERFIELD_PL	Cross Street: N/A	Location: W
ADA ID: 6EA44193967E	Ramp Type: Perp	Initial Pass/Fail: Fail	Overall Compliance: No
		Severity Score: 25

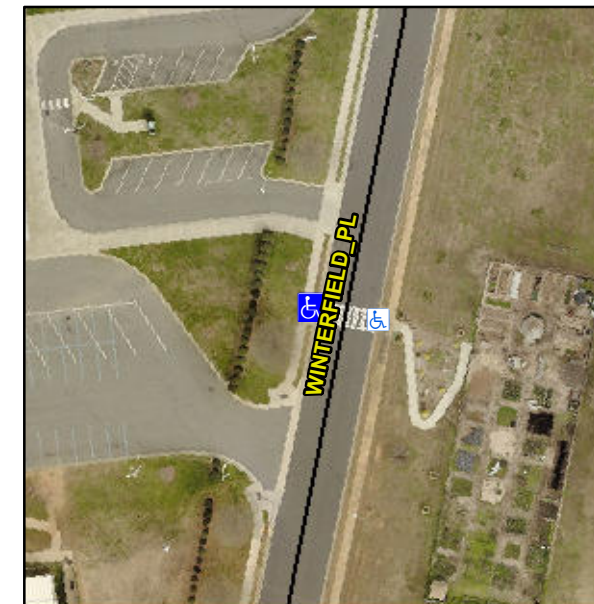
Not Found, R304.2.2

Compliance	Description	Data	Compliance	Description	Data
N/A	Ramp Length (in)	31.5	No	Ramp Slope (%)	13.2
Yes	Ramp Width (in)	48.0	Yes	Ramp XSlope (%)	0.4
N/A	Flare Type LT	N/A	N/A	Flare Type RT	N/A
N/A	Flare Slope LT (%)	N/A	N/A	Flare Slope RT (%)	N/A
N/A	Flare Traversable LT?	N/A	N/A	Flare Traversable RT?	N/A
N/A	Landing Length (in)	N/A	N/A	DWS Provided?	N/A
N/A	Landing Width (in)	N/A	N/A	DWS Contrast?	N/A
N/A	Landing Slope (%)	N/A	N/A	DWS Length (in)	N/A
N/A	Landing X Slope (%)	N/A	N/A	DWS Full Width?	N/A
N/A	Landing Curb? (Y/N)	N/A	N/A	DWS Offset (in)	N/A
N/A	Shared Landing?	N/A			
N/A	Gutter Ponding?	N/A	N/A	Gutter Slope (%)	N/A
N/A	Gutter Lip Ht (in)	N/A	N/A	Gutter X Slope (%)	N/A
N/A	Painted X Walk1?	Yes	N/A	Painted X Walk2?	N/A
	X Walk 1 Direction	To E		X Walk 2 Direction	N/A
N/A	X Walk 1 Width (in)	112.0	N/A	X Walk 2 Width (in)	N/A
	X Walk 1 Slope (%)	6.4		X Walk 2 Slope (%)	N/A
	X Walk 1 X Slope (%)	0.9		X Walk 2 X Slope (%)	N/A

N/A	Ramp inside XWalk1?	Yes	N/A	Ramp inside XWalk2?	N/A
	Road Slope (%)	N/A	N/A	Clear Space?	N/A
	Road X Slope (%)	N/A	N/A	Clear Space to XWalk (in)	N/A
N/A	Any Obstructions?	N/A	N/A	Storm Grate/Utility Hazard?	N/A
	Obstruction Type			Storm Grate/Utility Type	
		N/A			N/A
			Yes	Surface Condition? (G/P)	Good

Remove & Replace Entire Ramp.

Total Cost: \$ 1850.00
