# Access Compliance Report

## Public Rights-of-Way

### (Curb Ramps)

Intersection ID: 6841	Main Street: GARVIS_DR	Cross Street: ONEIDA_RD	Location: NW
ADA ID: 6EACCB54B1F5	Ramp Type: Perp	Initial Pass/Fail: Fail	Overall Compliance: No
Severity Score: 21.25			
Codes/Mitigation Info/Possible Solution		Field Measurements/Component Compliance

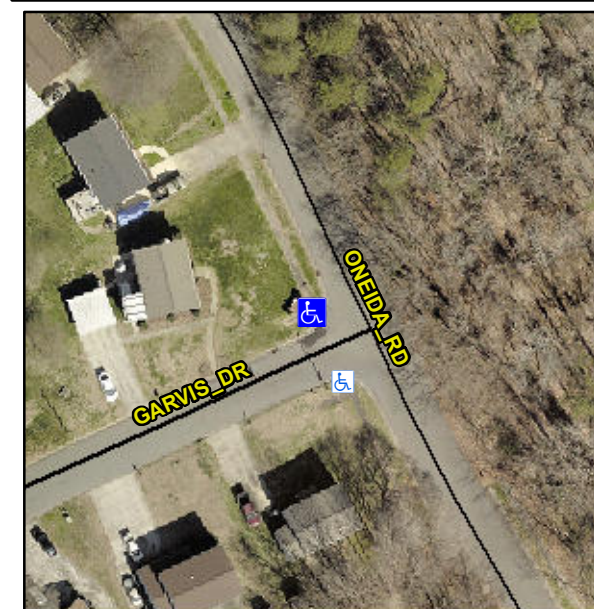
**Not Found, R304.5.1, R304.2.2**

Compliance	Description	Data	Compliance	Description	Data
N/A	Ramp Length (in)	43.0	No	Ramp Slope (%)	8.6
No	Ramp Width (in)	43.0	Yes	Ramp XSlope (%)	0.9
N/A	Flare Type LT	N/A	N/A	Flare Type RT	N/A
N/A	Flare Slope LT (%)	N/A	N/A	Flare Slope RT (%)	N/A
N/A	Flare Traversable LT?	N/A	N/A	Flare Traversable RT?	N/A
N/A	Landing Length (in)	N/A	N/A	DWS Provided?	N/A
N/A	Landing Width (in)	N/A	N/A	DWS Contrast?	N/A
N/A	Landing Slope (%)	N/A	N/A	DWS Length (in)	N/A
N/A	Landing X Slope (%)	N/A	N/A	DWS Full Width?	N/A
N/A	Landing Curb? (Y/N)	N/A	N/A	DWS Offset (in)	N/A
N/A	Shared Landing?	N/A			
N/A	Gutter Ponding?	N/A	N/A	Gutter Slope (%)	N/A
N/A	Gutter Lip Ht (in)	N/A	N/A	Gutter X Slope (%)	N/A
N/A	Painted X Walk1?	No	N/A	Painted X Walk2?	N/A
	X Walk 1 Direction	To S		X Walk 2 Direction	N/A
N/A	X Walk 1 Width (in)	N/A	N/A	X Walk 2 Width (in)	N/A
	X Walk 1 Slope (%)	1.8		X Walk 2 Slope (%)	N/A
	X Walk 1 X Slope (%)	1.1		X Walk 2 X Slope (%)	N/A

N/A	Ramp inside XWalk1?	N/A	N/A	Ramp inside XWalk2?	N/A
	Road Slope (%)	N/A	N/A	Clear Space?	N/A
	Road X Slope (%)	N/A	N/A	Clear Space to XWalk (in)	N/A
N/A	Any Obstructions?	N/A	N/A	Storm Grate/Utility Hazard?	N/A
	Obstruction Type			Storm Grate/Utility Type	
		N/A			N/A
		Yes		Surface Condition? (G/P)	Good

Possible Solutions:

**Remove & Replace Entire Ramp.**

Total Cost: \$ 1850.00
