Intersection ID: 42684	Main Street: SHARON_AV	Cross Street: SHARON_RD	Location:	NE
ADA ID: 6EB4E4D155FF	Ramp Type: ParaDiag	Initial Pass/Fail: Fail	Overall Compliance: No	Severity Score: 13.75

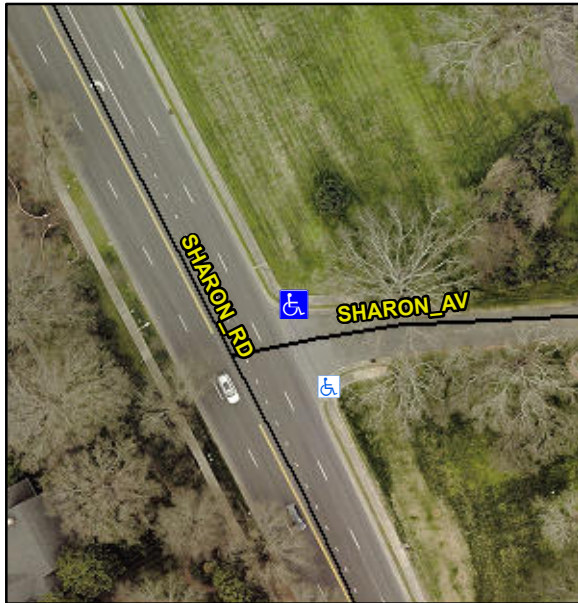
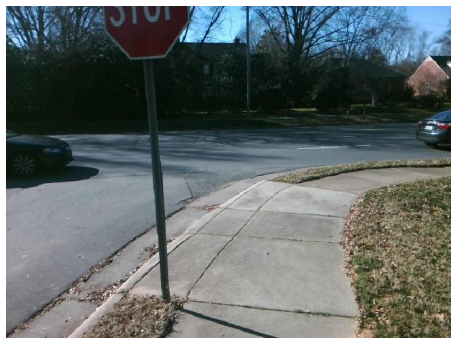
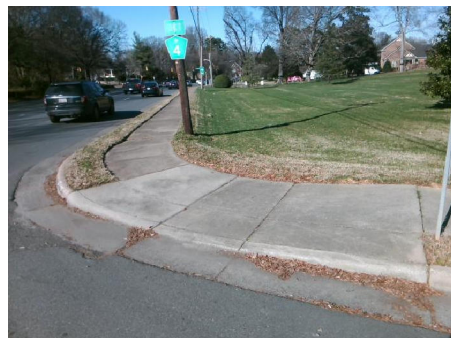
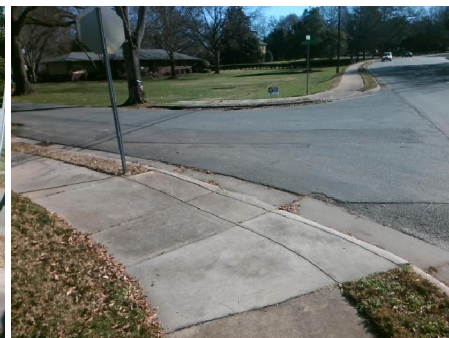
**R304.3.2, R304.5.3**

Compliance	Description	Data	Compliance	Description	Data
N/A	Ramp Length LT (in)	46.0	N/A	Ramp Length RT (in)	68.0
Yes	Ramp Width LT (in)	83.0	Yes	Ramp Width RT (in)	83.0
No	Ramp Slope LT (%)	9.1	Yes	Ramp Slope RT (%)	6.1
Yes	Ramp XSlope LT (%)	1.6	No	Ramp XSlope RT (%)	3.1
N/A	Landing Length (in)	N/A	N/A	DWS Provided?	N/A
N/A	Landing Width (in)	N/A	N/A	DWS Contrast?	N/A
N/A	Landing Slope (%)	N/A	N/A	DWS Length (in)	N/A
N/A	Landing X Slope (%)	N/A	N/A	DWS Full Width?	N/A
N/A	Landing Curb? (Y/N)	N/A	N/A	DWS Offset (in)	N/A
N/A	Shared Landing?	N/A			
N/A	Gutter Ponding?	N/A	N/A	Gutter Slope (%)	N/A
N/A	Gutter Lip Ht (in)	1.0	N/A	Gutter X Slope (%)	N/A
N/A	Painted X Walk1?	No	N/A	Painted X Walk2?	No
	X Walk 1 Direction	To W		X Walk 2 Direction	To S
N/A	X Walk 1 Width (in)	N/A	N/A	X Walk 2 Width (in)	N/A
	X Walk 1 Slope (%)	4.7		X Walk 2 Slope (%)	2.2
	X Walk 1 X Slope (%)	2.1		X Walk 2 X Slope (%)	1.9
N/A	Ramp inside XWalk1?	N/A	N/A	Ramp inside XWalk2?	N/A

Road Slope (%)	3.4	N/A	Clear Space?	N/A
	Road X Slope (%)	5.8	N/A	Clear Space to XWalk (in)	N/A
N/A	Any Obstructions?	N/A	N/A	Storm Grate/Utility Hazard?	N/A
	Obstruction Type			Storm Grate/Utility Type	
		N/A			N/A
			Yes	Surface Condition? (G/P)	Good
			N/A	Curb Slope (%)	5.0

**Remove & Replace Curb Ramp With Two New Directional Ramps or Equivalent.**
