Access Compliance Report Public Rights-of-Way (Curb Ramps)

Intersection ID: 2491 Main Street: LYNNEWOOD GLEN DR **Cross Street: MCCHESNEY DR** Location: **Overall Compliance: No ADA ID: 6EB5E6DAE134** Ramp Type: PerpDiag Initial Pass/Fail: Fail Severity Score: 13.75

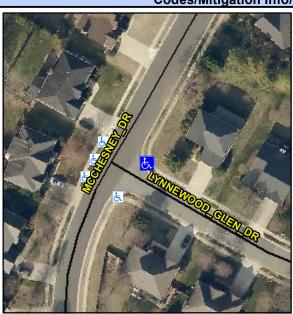
Total Cost: 3200.00 Compliance Description <u>Data</u> Compliance Description Data No N/A Ramp Length (in) 49.0 Ramp Slope (%) 9.4 No Yes Ramp Width (in) 48.0 Ramp XSlope (%) 2.3 N/A N/A Flare Type LT N/A Flare Type RT N/A N/A N/A N/A Flare Slope RT (%) N/A Flare Slope LT (%) N/A Flare Traversable LT? N/A N/A Flare Traversable RT? N/A N/A N/A N/A **DWS Provided?** N/A Landing Length (in) N/A Landing Width (in) N/A N/A **DWS Contrast?** N/A N/A N/A Landing Slope (%) N/A DWS Length (in) N/A N/A Landing X Slope (%) N/A N/A DWS Full Width? N/A N/A Landing Curb? (Y/N) N/A N/A DWS Offset (in) N/A N/A N/A Shared Landing? N/A **Gutter Ponding?** N/A N/A Gutter Slope (%) N/A N/A Gutter Lip Ht (in) N/A N/A Gutter X Slope (%) N/A N/A Painted X Walk1? No N/A Painted X Walk2? No X Walk 1 Direction To NW X Walk 2 Direction To SW N/A N/A X Walk 1 Width (in) N/A X Walk 2 Width (in) N/A X Walk 1 Slope (%) 5.7 X Walk 2 Slope (%) 1.9 X Walk 2 X Slope (%) X Walk 1 X Slope (%) 0.4 1.9 N/A N/A N/A Ramp inside XWalk2? N/A Ramp inside XWalk1? Road Slope (%) 0.9 N/A Clear Space? N/A N/A Road X Slope (%) Clear Space to XWalk (in) N/A 1.9 N/A N/A N/A Any Obstructions? Storm Grate/Utility Hazard? N/A **Obstruction Type**

MCCHESNEY DR None LYNNEWOOD GLEN DR StopSign Possible Solutions: Remove & Replace Curb Ramp With Two New Directional Ramps or Equivalent. Surveyor Notes: N/A PROW/ADA: R304.2.2, R304.5.3
