Access Compliance Report

Public Rights-of-Way

(Curb Ramps)

Intersection ID: 46304	Main Street: AUGUSTINE_WY	Cross Street: MERMANS_RD	Location: NE
ADA ID: 6EBFFDF95778	Ramp Type: PerpDiag	Initial Pass/Fail: Fail	Overall Compliance: No
Severity Score: 21.25			
Codes/Mitigation Info/Possible Solution		Field Measurements/Component Compliance

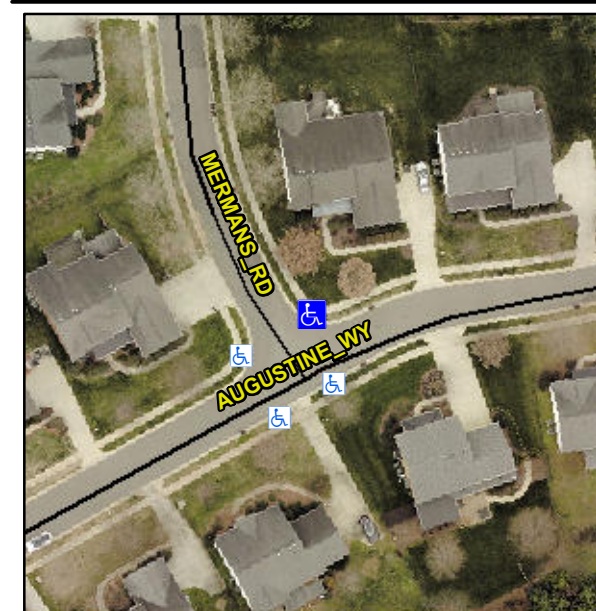
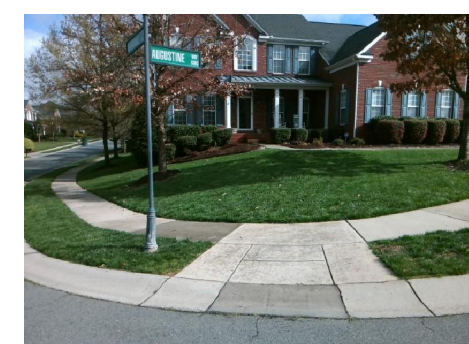
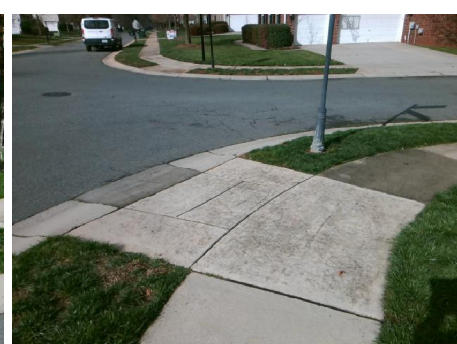
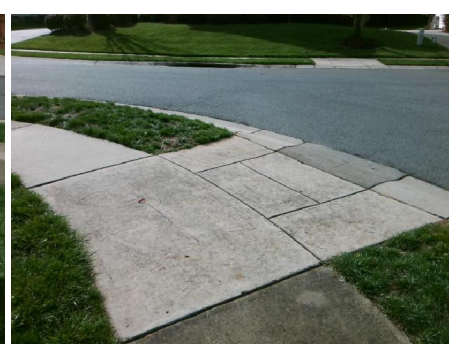
Not Found, R304.5.1, R304.5.3

Compliance	Description	Data	Compliance	Description	Data
N/A	Ramp Length (in)	46.5	Yes	Ramp Slope (%)	7.5
No	Ramp Width (in)	39.0	No	Ramp XSlope (%)	6.6
N/A	Flare Type LT	N/A	N/A	Flare Type RT	N/A
N/A	Flare Slope LT (%)	N/A	N/A	Flare Slope RT (%)	N/A
N/A	Flare Traversable LT?	N/A	N/A	Flare Traversable RT?	N/A
N/A	Landing Length (in)	N/A	N/A	DWS Provided?	N/A
N/A	Landing Width (in)	N/A	N/A	DWS Contrast?	N/A
N/A	Landing Slope (%)	N/A	N/A	DWS Length (in)	N/A
N/A	Landing X Slope (%)	N/A	N/A	DWS Full Width?	N/A
N/A	Landing Curb? (Y/N)	N/A	N/A	DWS Offset (in)	N/A
N/A	Shared Landing?	N/A			
N/A	Gutter Ponding?	N/A	N/A	Gutter Slope (%)	N/A
N/A	Gutter Lip Ht (in)	N/A	N/A	Gutter X Slope (%)	N/A
N/A	Painted X Walk1?	No	N/A	Painted X Walk2?	No
	X Walk 1 Direction	To W		X Walk 2 Direction	To S
N/A	X Walk 1 Width (in)	N/A	N/A	X Walk 2 Width (in)	N/A
	X Walk 1 Slope (%)	0.4		X Walk 2 Slope (%)	5.9
	X Walk 1 X Slope (%)	5.9		X Walk 2 X Slope (%)	3.6

N/A	Ramp inside XWalk1?	N/A	N/A	Ramp inside XWalk2?	N/A
	Road Slope (%)	5.8	N/A	Clear Space?	N/A
	Road X Slope (%)	4.0	N/A	Clear Space to XWalk (in)	N/A
N/A	Any Obstructions?	N/A	N/A	Storm Grate/Utility Hazard?	N/A
	Obstruction Type			Storm Grate/Utility Type	
		N/A			N/A
		Yes		Surface Condition? (G/P)	Good

Remove & Replace Curb Ramp With Two New Directional Ramps or Equivalent.
