Access Compliance Report

Public Rights-of-Way

(Curb Ramps)

Intersection ID: 10025341	Main Street: E_7TH_ST	Cross Street: N/A	Location: S
ADA ID: 6EDBDFB30ADA	Ramp Type: Perp	Initial Pass/Fail: Pass	Overall Compliance: No
		Severity Score: 0	
Codes/Mitigation Info/Possible Solution		Field Measurements/Component Compliance

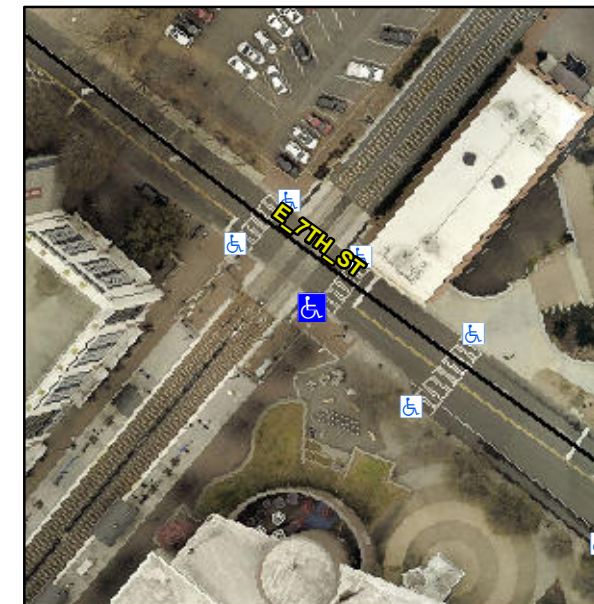
Not Found, R304.2.2-Perp, R304.3.2-Para

Compliance	Description	Data	Compliance	Description	Data
N/A	Ramp Length (in)	48.0	Yes	Ramp Slope (%)	5.2
Yes	Ramp Width (in)	48.0	Yes	Ramp XSlope (%)	0.5
N/A	Flare Type LT	Sloped	N/A	Flare Type RT	N/A
N/A	Flare Slope LT (%)	5.0	Yes	Flare Slope RT (%)	4.6
N/A	Flare Traversable LT?	Yes	N/A	Flare Traversable RT?	Yes
Yes	Landing Length (in)	48.0	Yes	DWS Provided?	Yes
Yes	Landing Width (in)	48.0	Yes	DWS Contrast?	Yes
No	Landing Slope (%)	3.3	Yes	DWS Length (in)	24.0
Yes	Landing X Slope (%)	0.4	Yes	DWS Full Width?	Yes
N/A	Landing Curb? (Y/N)	No	Yes	DWS Offset (in)	0.0
N/A	Shared Landing?	No			
Yes	Gutter Ponding?	No	Yes	Gutter Slope (%)	1.5
Yes	Gutter Lip Ht (in)	0.0	Yes	Gutter X Slope (%)	0.8
N/A	Painted X Walk1?	Yes	N/A	Painted X Walk2?	N/A
	X Walk 1 Direction	To NE		X Walk 2 Direction	N/A
N/A	X Walk 1 Width (in)	111.0	N/A	X Walk 2 Width (in)	N/A
	X Walk 1 Slope (%)	1.1		X Walk 2 Slope (%)	N/A
	X Walk 1 X Slope (%)	0.6		X Walk 2 X Slope (%)	N/A

Yes	Ramp inside XWalk1?	Yes	N/A	Ramp inside XWalk2?	N/A
	Road Slope (%)	N/A	N/A	Clear Space?	Yes
	Road X Slope (%)	N/A	N/A	Clear Space to XWalk (in)	N/A
Yes	Any Obstructions?	No	Yes	Storm Grate/Utility Hazard?	No
	Obstruction Type			Storm Grate/Utility Type	
		N/A			N/A
			Yes	Surface Condition? (G/P)	Good

Possible Solutions:

Remove & Replace Entire Ramp.
