# Access Compliance Report

## Public Rights-of-Way

### (Curb Ramps)

| Intersection ID: 25942 | Main Street: ELM_LN | Cross Street: OLD_WELL_HOUSE_RD | Location: N |

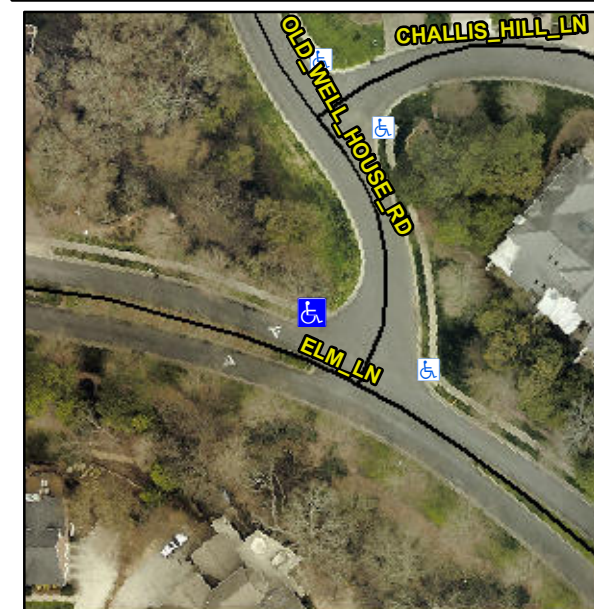
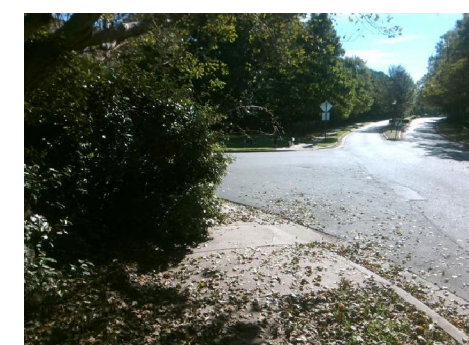
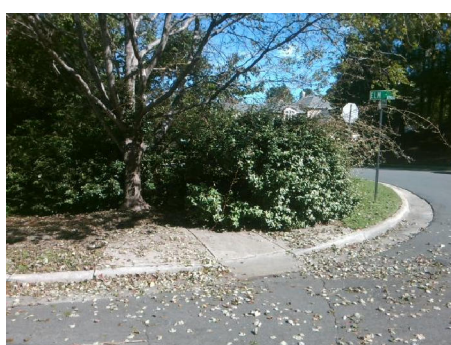
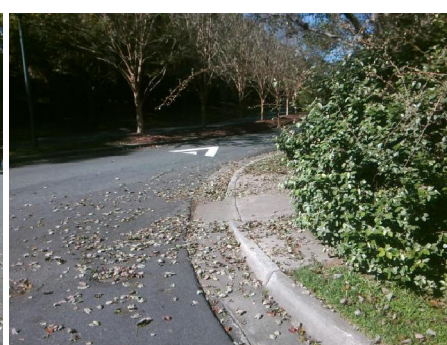
| ADA ID: 6EE05E37A321 | Ramp Type: Perp | Initial Pass/Fail: Fail | Overall Compliance: No |

**Not Found, R304.5.1, R304.2.2**

| Compliance | Description | Data | Compliance | Description | Data |
|---|---|---|---|---|---|
| N/A | Ramp Length (in) | 84.0 | No | Ramp Slope (%) | 9.3 |
| No | Ramp Width (in) | 46.0 | Yes | Ramp XSlope (%) | 0.0 |

**Remove & Replace Entire Ramp.**

Total Cost: \$ 1850.00
