Access Compliance Report Public Rights-of-Way (Curb Ramps)

Intersection ID: 11771
 Main Street:
 SHAMROCK_DR
 Cross Street:
 WINEDALE_LN
 Location:
 W

ADA ID: 6EE25F491BBC
 Ramp Type:
 Perp
 Initial Pass/Fail:
 Fail
 Overall Compliance:
 No
 Severity Score:
 21.25

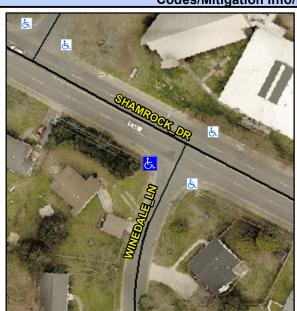
Not Found, R304.5.1, R304.2.2

Field Measurements/Component Compliance						
Compliance Description		Data	Compliance		Description	Data
N/A	Ramp Length (in)	60.0	No	Ramp	Slope (%)	9.5
No	Ramp Width (in)	42.0	Yes	Ramp	XSlope (%)	0.6
N/A	Flare Type LT	N/A	N/A	Flare	Type RT	N/A
N/A	Flare Slope LT (%)	N/A	N/A	Flare	Slope RT (%)	N/A
N/A	Flare Traversable LT?	N/A	N/A	Flare	Traversable RT?	N/A
N/A	Landing Length (in)	N/A	N/A	DWS	Provided?	N/A
N/A	Landing Width (in)	N/A	N/A	DWS	Contrast?	N/A
N/A	Landing Slope (%)	N/A	N/A	DWS	Length (in)	N/A
N/A	Landing X Slope (%)	N/A	N/A	DWS	Full Width?	N/A
N/A	Landing Curb? (Y/N)	N/A	N/A	DWS	Offset (in)	N/A
N/A	Shared Landing?	N/A				
N/A	Gutter Ponding?	N/A	N/A	Gutte	r Slope (%)	N/A
N/A	Gutter Lip Ht (in)	N/A	N/A	Gutte	r X Slope (%)	N/A
N/A	Painted X Walk1?	No	N/A	Painte	ed X Walk2?	N/A
	X Walk 1 Direction	To SE		X Wal	lk 2 Direction	N/A
N/A	X Walk 1 Width (in)	N/A	N/A	X Wal	lk 2 Width (in)	N/A
	X Walk 1 Slope (%)	1.3		X Wal	lk 2 Slope (%)	N/A

Remove & Replace Entire Ramp.
