Access Compliance Report

Public Rights-of-Way

(Curb Ramps)

Intersection ID: N/A	Main Street: SOUTH_BV	Cross Street: HEBRON_ST	Location: NE
ADA ID: 6EF81C83B7AF	Ramp Type: Perp	Initial Pass/Fail: Fail	Overall Compliance: No
Severity Score: 12.5			
Codes/Mitigation Info/Possible Solution		Field Measurements/Component Compliance

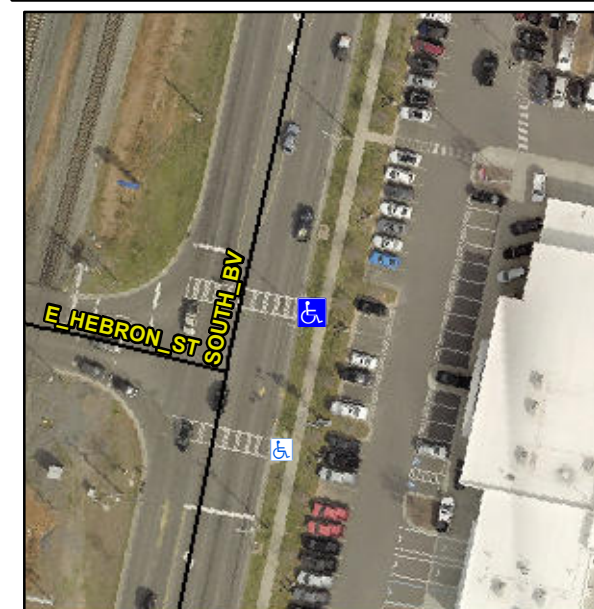
Compliance	Description	Data	Compliance	Description	Data
N/A	Ramp Length (in)	96.0	No	Ramp Slope (%)	8.6
Yes	Ramp Width (in)	60.0	Yes	Ramp XSlope (%)	1.1
N/A	Flare Type LT	N/A	N/A	Flare Type RT	N/A
N/A	Flare Slope LT (%)	N/A	N/A	Flare Slope RT (%)	N/A
N/A	Flare Traversable LT?	N/A	N/A	Flare Traversable RT?	N/A
N/A	Landing Length (in)	N/A	N/A	DWS Provided?	N/A
N/A	Landing Width (in)	N/A	N/A	DWS Contrast?	N/A
N/A	Landing Slope (%)	N/A	N/A	DWS Length (in)	N/A
N/A	Landing X Slope (%)	N/A	N/A	DWS Full Width?	N/A
N/A	Landing Curb? (Y/N)	N/A	N/A	DWS Offset (in)	N/A
N/A	Shared Landing?	N/A			
N/A	Gutter Ponding?	N/A	N/A	Gutter Slope (%)	N/A
N/A	Gutter Lip Ht (in)	N/A	N/A	Gutter X Slope (%)	N/A
N/A	Painted X Walk1?	Yes	N/A	Painted X Walk2?	N/A
	X Walk 1 Direction	To W		X Walk 2 Direction	N/A
N/A	X Walk 1 Width (in)	114.0	N/A	X Walk 2 Width (in)	N/A
	X Walk 1 Slope (%)	4.5		X Walk 2 Slope (%)	N/A
	X Walk 1 X Slope (%)	0.7		X Walk 2 X Slope (%)	N/A

N/A	Ramp inside XWalk1?	Yes	N/A	Ramp inside XWalk2?	N/A
	Road Slope (%)	N/A	N/A	Clear Space?	N/A
	Road X Slope (%)	N/A	N/A	Clear Space to XWalk (in)	N/A
N/A	Any Obstructions?	N/A	N/A	Storm Grate/Utility Hazard?	N/A
	Obstruction Type			Storm Grate/Utility Type	
		N/A			N/A
		Yes		Surface Condition? (G/P)	Good

Possible Solutions:

Remove & Replace Entire Ramp.

R304.2.2

Total Cost: \$ 1850.00
