# Access Compliance Report

## Public Rights-of-Way

### (Curb Ramps)

| Intersection ID: 14812 | Main Street: KENMORE_AV | Cross Street: N_DOTGER_AV | Location: NW |

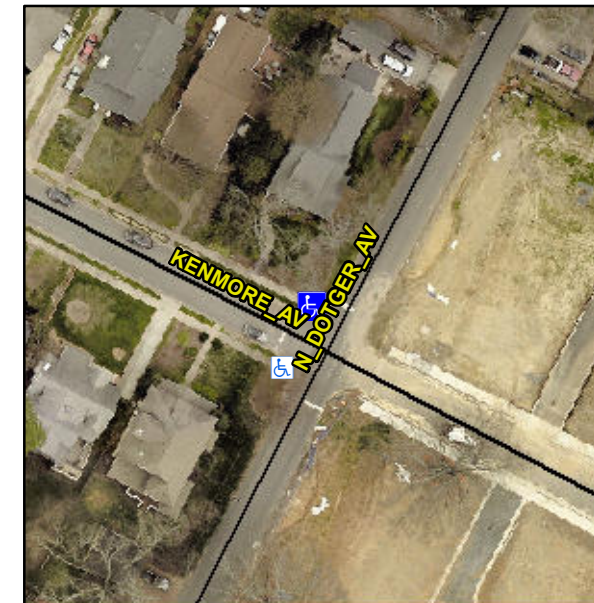
| ADA ID: 6EFD3DBE27DD | Ramp Type: PerpDiag | Initial Pass/Fail: Fail | Overall Compliance: No |
| | | Severity Score: 25 | |

**Not Found, R304.2.2, R304.5.3**

| Compliance | Description | Data | Compliance | Description | Data |
|---|---|---|---|---|---|
| N/A | Ramp Length (in) | 26.0 | No | Ramp Slope (%) | 11.3 |
| Yes | Ramp Width (in) | 48.0 | No | Ramp XSlope (%) | 5.1 |

Possible Solutions:

**Remove & Replace Curb Ramp With Two New Directional Ramps or Equivalent.**

Total Cost: \$ 3200.00

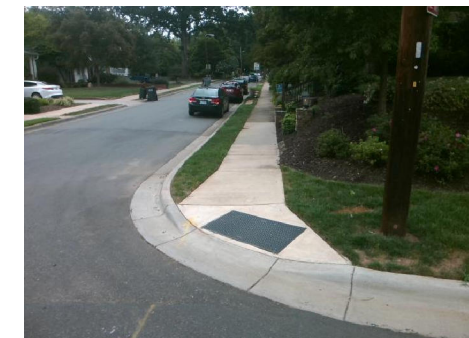
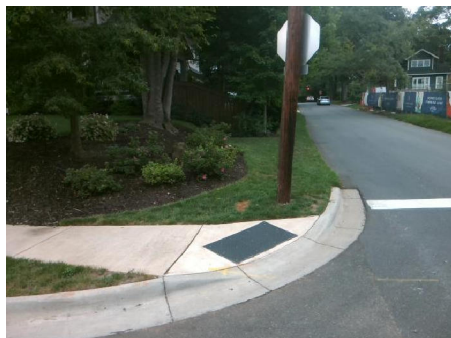
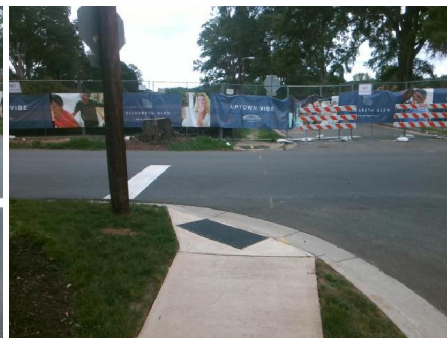
| Compliance | Description | Data | Compliance | Description | Data |
|---|---|---|---|---|---|
| | | Yes | | Surface Condition? (G/P) | Good |
