Access Compliance Report

Public Rights-of-Way

(Curb Ramps)

Intersection ID: 53880	Main Street: PAWTUCKETT_RD	Cross Street: PAW_VILLAGE_RD	Location:	W
ADA ID: 6EFD3EC9BD42	Ramp Type: Perp	Initial Pass/Fail: Fail	Overall Compliance: No	Severity Score: 10
Codes/Mitigation Info/Possible Solution		Field Measurements/Component Compliance

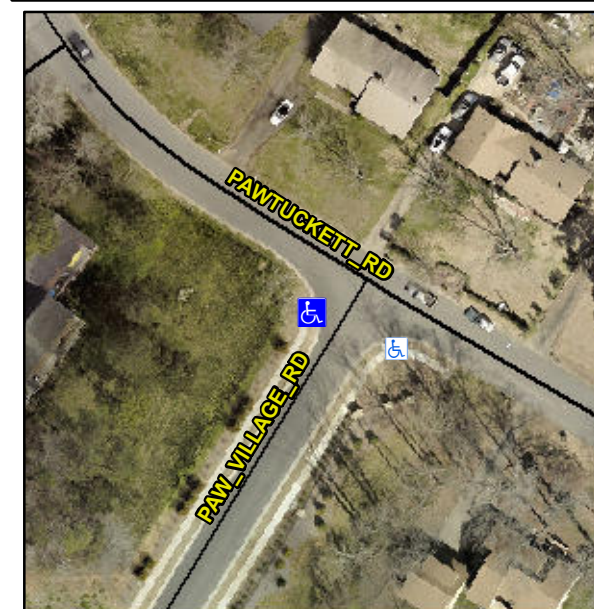
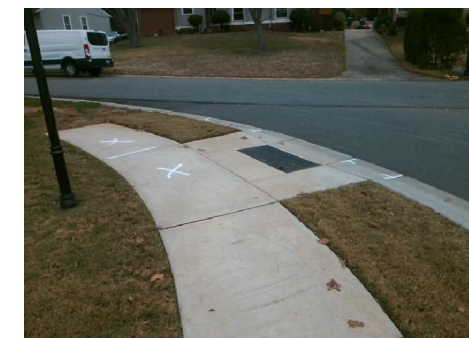
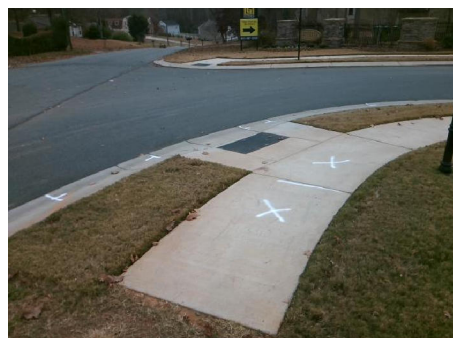
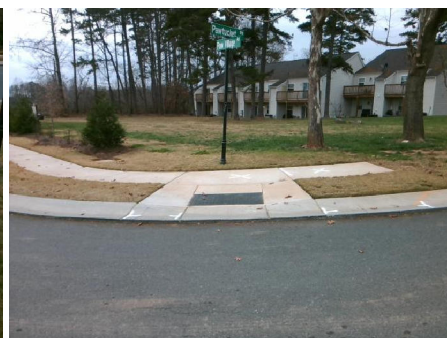
Compliance	Description	Data	Compliance	Description	Data
N/A	Ramp Length (in)	48.0	Yes	Ramp Slope (%)	6.9
No	Ramp Width (in)	47.0	No	Ramp XSlope (%)	4.8
N/A	Flare Type LT	N/A	N/A	Flare Type RT	N/A
N/A	Flare Slope LT (%)	N/A	N/A	Flare Slope RT (%)	N/A
N/A	Flare Traversable LT?	N/A	N/A	Flare Traversable RT?	N/A
N/A	Landing Length (in)	N/A	N/A	DWS Provided?	N/A
N/A	Landing Width (in)	N/A	N/A	DWS Contrast?	N/A
N/A	Landing Slope (%)	N/A	N/A	DWS Length (in)	N/A
N/A	Landing X Slope (%)	N/A	N/A	DWS Full Width?	N/A
N/A	Landing Curb? (Y/N)	N/A	N/A	DWS Offset (in)	N/A
N/A	Shared Landing?	N/A			
N/A	Gutter Ponding?	N/A	N/A	Gutter Slope (%)	N/A
N/A	Gutter Lip Ht (in)	N/A	N/A	Gutter X Slope (%)	N/A
N/A	Painted X Walk1?	No	N/A	Painted X Walk2?	N/A
	X Walk 1 Direction	To SE		X Walk 2 Direction	N/A
N/A	X Walk 1 Width (in)	N/A	N/A	X Walk 2 Width (in)	N/A
	X Walk 1 Slope (%)	3.8		X Walk 2 Slope (%)	N/A
	X Walk 1 X Slope (%)	1.4		X Walk 2 X Slope (%)	N/A

N/A	Ramp inside XWalk1?	N/A	N/A	Ramp inside XWalk2?	N/A
	Road Slope (%)	N/A	N/A	Clear Space?	N/A
	Road X Slope (%)	N/A	N/A	Clear Space to XWalk (in)	N/A
N/A	Any Obstructions?	N/A	N/A	Storm Grate/Utility Hazard?	N/A
	Obstruction Type			Storm Grate/Utility Type	
		N/A			N/A
			Yes	Surface Condition? (G/P)	Good

Possible Solutions:

Remove & Replace Entire Ramp.

R304.5.1, R304.5.3
