Access Compliance Report

Public Rights-of-Way

(Curb Ramps)

Intersection ID: 10024489	Main Street: CROWN_CRESCENT_CT	Cross Street: N/A	Location: SW
ADA ID: 6F001049C214	Ramp Type: PerpDiag	Initial Pass/Fail: Fail	Overall Compliance: No
Severity Score: 33.75			
Codes/Mitigation Info/Possible Solution		Field Measurements/Component Compliance

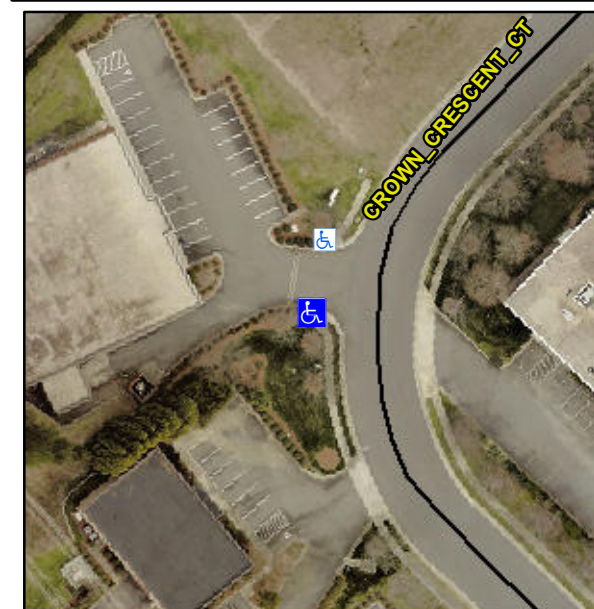
Not Found, R304.5.1, R304.5.3

Compliance	Description	Data	Compliance	Description	Data
N/A	Ramp Length (in)	48.0	Yes	Ramp Slope (%)	5.5
No	Ramp Width (in)	42.0	No	Ramp XSlope (%)	12.2
N/A	Flare Type LT	N/A	N/A	Flare Type RT	N/A
N/A	Flare Slope LT (%)	N/A	N/A	Flare Slope RT (%)	N/A
N/A	Flare Traversable LT?	N/A	N/A	Flare Traversable RT?	N/A
N/A	Landing Length (in)	N/A	N/A	DWS Provided?	N/A
N/A	Landing Width (in)	N/A	N/A	DWS Contrast?	N/A
N/A	Landing Slope (%)	N/A	N/A	DWS Length (in)	N/A
N/A	Landing X Slope (%)	N/A	N/A	DWS Full Width?	N/A
N/A	Landing Curb? (Y/N)	N/A	N/A	DWS Offset (in)	N/A
N/A	Shared Landing?	N/A			
N/A	Gutter Ponding?	N/A	N/A	Gutter Slope (%)	N/A
N/A	Gutter Lip Ht (in)	N/A	N/A	Gutter X Slope (%)	N/A
N/A	Painted X Walk1?	No	N/A	Painted X Walk2?	No
	X Walk 1 Direction	To E		X Walk 2 Direction	To N
N/A	X Walk 1 Width (in)	N/A	N/A	X Walk 2 Width (in)	N/A
	X Walk 1 Slope (%)	12.4		X Walk 2 Slope (%)	2.1
	X Walk 1 X Slope (%)	3.5		X Walk 2 X Slope (%)	13.9

N/A	Ramp inside XWalk1?	N/A	N/A	Ramp inside XWalk2?	N/A
	Road Slope (%)	10.8	N/A	Clear Space?	N/A
	Road X Slope (%)	1.5	N/A	Clear Space to XWalk (in)	N/A
N/A	Any Obstructions?	N/A	N/A	Storm Grate/Utility Hazard?	N/A
	Obstruction Type			Storm Grate/Utility Type	
		N/A			N/A
			Yes	Surface Condition? (G/P)	Good

Remove & Replace Curb Ramp With Two New Directional Ramps or Equivalent.
