Access Compliance Report

Public Rights-of-Way

(Curb Ramps)

Intersection ID: 10180	Main Street: FERN_AV	Cross Street: TUCKASEEGEE_RD	Location: S
ADA ID: 6F16496D74C9	Ramp Type: Directional1	Initial Pass/Fail: Fail	Overall Compliance: No
		Severity Score: 12.5

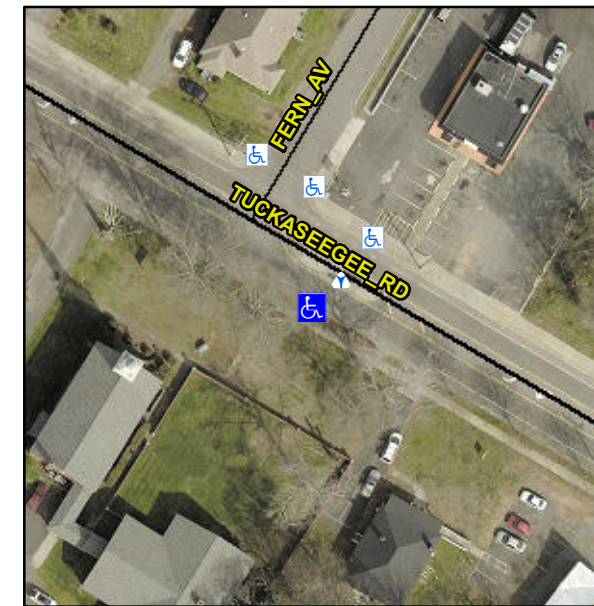
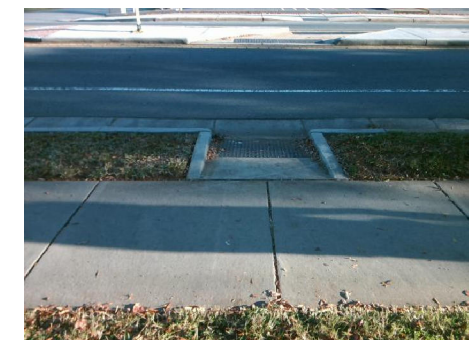
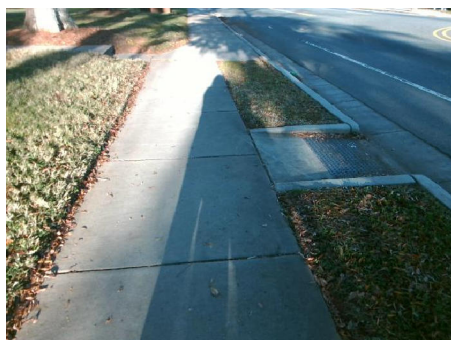
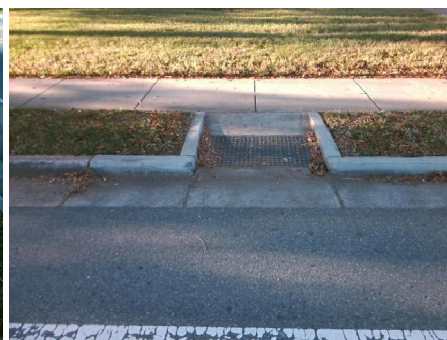
Compliance	Description	Data	Compliance	Description	Data
N/A	Ramp Length (in)	49.0	N/A	Grade Break?	N/A
Yes	Ramp Width (in)	48.0	N/A	Grade Break Slope (%)	0.0
No	Ramp Slope (%)	10.2	N/A	Grade Break XSlope (%)	0.0
Yes	Ramp XSlope (%)	0.6			
N/A	Flare Type LT	N/A	N/A	Flare Type RT	N/A
N/A	Flare Slope LT (%)	N/A	N/A	Flare Slope RT (%)	0.0
N/A	Flare Traversable LT?	N/A	N/A	Flare Traversable RT?	N/A
N/A	Landing Length (in)	0.0	N/A	DWS Provided?	N/A
N/A	Landing Width (in)	0.0	N/A	DWS Contrast?	N/A
N/A	Landing Slope (%)	0.0	N/A	DWS Length (in)	N/A
N/A	Landing X Slope (%)	0.0	N/A	DWS Full Width?	N/A
N/A	Landing Curb? (Y/N)	N/A	N/A	DWS Offset LT (in)	N/A
N/A	Shared Landing?	N/A	N/A	DWS Offset RT (in)	N/A
N/A	Gutter Ponding?	0.0	N/A	Gutter Slope (%)	N/A
N/A	Gutter Lip Ht (in)	0.0	N/A	Gutter X Slope (%)	N/A
N/A	Painted X Walk1?	No		Road Slope (%)	6.5
	X Walk 1 Direction	To N		Road X Slope (%)	1.3
	X Walk 1 Width (in)	N/A		Clear Space?	N/A

X Walk 1 Slope (%)	6.5	N/A	Clear Space to XWalk (in)	N/A
	X Walk 1 X Slope (%)	1.3	N/A	Storm Grate/Utility Hazard?	N/A
N/A	Ramp inside XWalk1?	N/A		Storm Grate/Utility Type	
N/A	Any Obstructions?	N/A			N/A
	Obstruction Type		Yes	Surface Condition? (G/P)	Good
			N/A	Curb Slope (%)	11.5

Remove & Replace Entire Ramp.
