Access Compliance Report

Public Rights-of-Way

(Curb Ramps)

Intersection ID: 10015635	Main Street: HARRIS_CORNERS_PY	Cross Street: N/A	Location: S
ADA ID: 6F18EBEB26CE	Ramp Type: PerpDiag	Initial Pass/Fail: Fail	Overall Compliance: No
Severity Score: 17.5			
Codes/Mitigation Info/Possible Solution		Field Measurements/Component Compliance

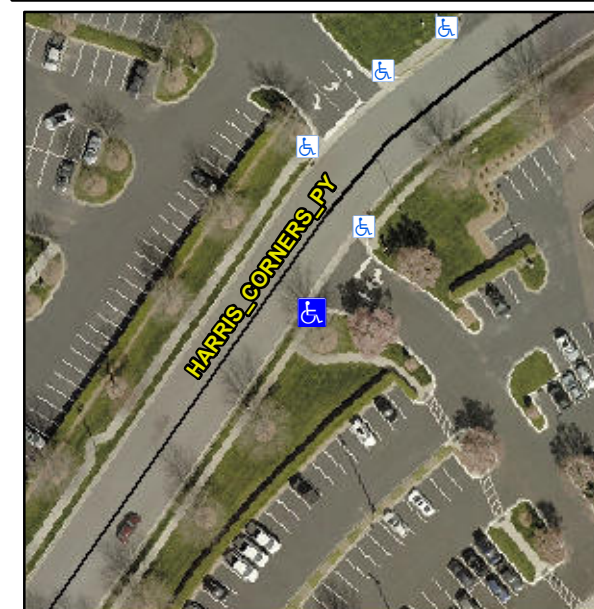
Compliance	Description	Data	Compliance	Description	Data
N/A	Ramp Length (in)	69.0	Yes	Ramp Slope (%)	6.4
No	Ramp Width (in)	35.0	Yes	Ramp XSlope (%)	1.2
N/A	Flare Type LT	N/A	N/A	Flare Type RT	N/A
N/A	Flare Slope LT (%)	N/A	N/A	Flare Slope RT (%)	N/A
N/A	Flare Traversable LT?	N/A	N/A	Flare Traversable RT?	N/A
N/A	Landing Length (in)	N/A	N/A	DWS Provided?	N/A
N/A	Landing Width (in)	N/A	N/A	DWS Contrast?	N/A
N/A	Landing Slope (%)	N/A	N/A	DWS Length (in)	N/A
N/A	Landing X Slope (%)	N/A	N/A	DWS Full Width?	N/A
N/A	Landing Curb? (Y/N)	N/A	N/A	DWS Offset (in)	N/A
N/A	Shared Landing?	N/A			
N/A	Gutter Ponding?	N/A	N/A	Gutter Slope (%)	N/A
N/A	Gutter Lip Ht (in)	N/A	N/A	Gutter X Slope (%)	N/A
N/A	Painted X Walk1?	No	N/A	Painted X Walk2?	No
	X Walk 1 Direction	To NE		X Walk 2 Direction	To NW
N/A	X Walk 1 Width (in)	N/A	N/A	X Walk 2 Width (in)	N/A
	X Walk 1 Slope (%)	0.7		X Walk 2 Slope (%)	2.8
	X Walk 1 X Slope (%)	1.5		X Walk 2 X Slope (%)	1.7

N/A	Ramp inside XWalk1?	N/A	N/A	Ramp inside XWalk2?	N/A
	Road Slope (%)	1.5	N/A	Clear Space?	N/A
	Road X Slope (%)	0.4	N/A	Clear Space to XWalk (in)	N/A
N/A	Any Obstructions?	N/A	N/A	Storm Grate/Utility Hazard?	N/A
	Obstruction Type			Storm Grate/Utility Type	
		N/A			N/A
			Yes	Surface Condition? (G/P)	Good

Remove & Replace Curb Ramp With Two New Directional Ramps or Equivalent.

R304.5.1

Total Cost: \$ 3200.00
