Access Compliance Report Public Rights-of-Way (Curb Ramps)

Intersection ID: 23181 Main Street: GLENEAGLES RD Cross Street: BAR HARBOR LN Location: NW **Overall Compliance: No Severity Score:** ADA ID: 6F29946F86FF Ramp Type: ParaDiag Initial Pass/Fail: Fail 12.5

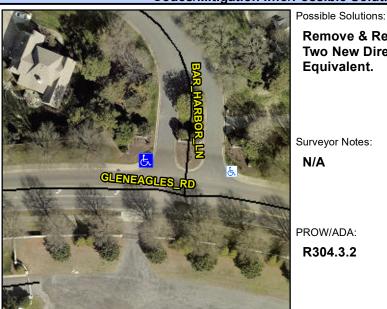
Compliance Description Data Compliance Description Data N/A N/A N/A Ramp Length LT (in) Ramp Length RT (in) 63.0 N/A N/A Ramp Width LT (in) Yes Ramp Width RT (in) 60.0 N/A Ramp Slope LT (%) N/A No Ramp Slope RT (%) 11.6 N/A Ramp XSlope LT (%) N/A Yes Ramp XSlope RT (%) 1.9 N/A Landing Length (in) N/A N/A DWS Provided? N/A N/A Landing Width (in) N/A N/A **DWS Contrast?** N/A N/A Landing Slope (%) N/A N/A DWS Length (in) N/A N/A Landing X Slope (%) N/A N/A DWS Full Width? N/A N/A Landing Curb? (Y/N) N/A N/A DWS Offset (in) N/A Shared Landing? N/A N/A N/A Gutter Ponding? Gutter Slope (%) N/A Gutter Lip Ht (in) N/A N/A Gutter X Slope (%) N/A Painted X Walk1? No N/A Painted X Walk2? No X Walk 1 Direction To S X Walk 2 Direction To E X Walk 1 Width (in) N/A N/A X Walk 2 Width (in) N/A X Walk 1 Slope (%) 1.6 X Walk 2 Slope (%) 4.8 X Walk 1 X Slope (%) 3.4 X Walk 2 X Slope (%) 0.2 Ramp inside XWalk1? N/A N/A Ramp inside XWalk2? N/A 1.1 N/A N/A Road Slope (%) Clear Space? Road X Slope (%) 6.3 N/A Clear Space to XWalk (in) N/A N/A Any Obstructions? N/A Storm Grate/Utility Hazard? N/A Obstruction Type Storm Grate/Utility Type N/A N/A Yes Surface Condition? (G/P) Good N/A Curb Slope (%) 6.9

Street 1 Name Stop Condition-Street 1 Street 2 Name Stop Condition-Street 2 Remove & Replace Curb Ramp With Two New Directional Ramps or Equivalent.

R304.3.2

N/A N/A N/A N/A N/A N/A N/A Total Cost: 3200.00
