Access Compliance Report

Public Rights-of-Way

(Curb Ramps)

Intersection ID: 50272	Main Street: SOUTH_BV	Cross Street: WHITTON_ST	Location: S
ADA ID: 6F2F475EFF45	Ramp Type: BlendTrans1	Initial Pass/Fail: Pass	Overall Compliance: No
		Severity Score: 7.5

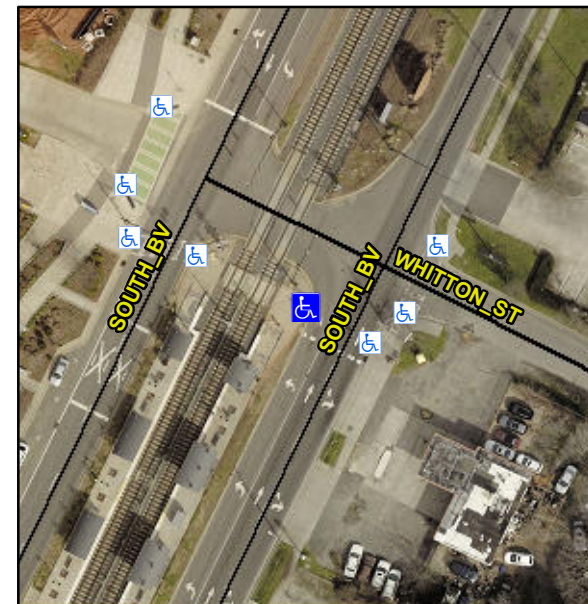
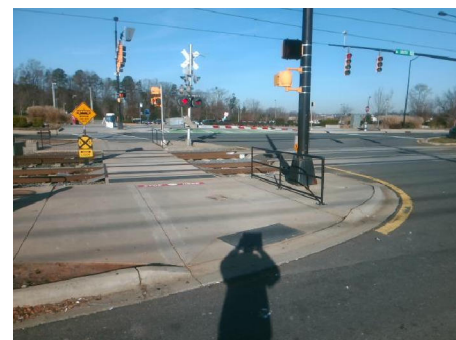
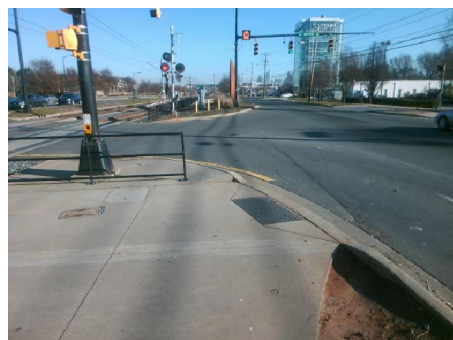
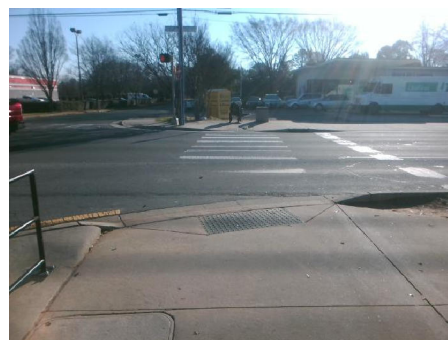
Not Found, R304.5.3, R305.1.4, R304.5.4

Compliance	Description	Data	Compliance	Description	Data
N/A	Ramp Length (in)	48.0	Yes	BlendTrans Slope (%)	0.1
Yes	Ramp Width (in)	48.0	Yes	BlendTrans XSlope (%)	1.7
N/A	Flare Type LT	Sloped	N/A	Flare Type RT	Sloped
N/A	Flare Slope LT (%)	1.6	N/A	Flare Slope RT (%)	0.6
N/A	Flare Traversable LT?	No	N/A	Flare Traversable RT?	No
Yes	Landing Length (in)	48.0	Yes	DWS Provided?	Yes
Yes	Landing Width (in)	48.0	Yes	DWS Contrast?	Yes
Yes	Landing Slope (%)	1.0	Yes	DWS Length (in)	24.0
No	Landing X Slope (%)	2.2	No	DWS Full Width?	No
N/A	Landing Curb? (Y/N)	No	Yes	DWS Offset (in)	1.0
N/A	Shared Landing?	No			
Yes	Gutter Ponding?	No	No	Gutter Slope (%)	6.6
Yes	Gutter Lip Ht (in)	0.0	No	Gutter X Slope (%)	2.3
N/A	Painted X Walk1?	Yes	N/A	Painted X Walk2?	N/A
	X Walk 1 Direction	To E		X Walk 2 Direction	N/A
	X Walk 1 Width (in)	112.0		X Walk 2 Width (in)	N/A
	X Walk 1 Slope (%)	1.5		X Walk 2 Slope (%)	N/A
	X Walk 1 X Slope (%)	0.6		X Walk 2 X Slope (%)	N/A

Yes	Ramp inside XWalk1?	Yes	N/A	Ramp inside XWalk2?	N/A
	Road Slope (%)	0.6		Clear Space?	Yes
	Road X Slope (%)	1.5	N/A	Clear Space to XWalk (in)	N/A
Yes	Any Obstructions?	No	Yes	Storm Grate/Utility Hazard?	No
	Obstruction Type			Storm Grate/Utility Type	
		N/A			N/A
			Yes	Surface Condition? (G/P)	Good
			No	Curb Slope (%)	7.4

Remove & Replace Curb Ramp With Two New Directional Ramps or Equivalent. Remove & Replace Gutter.
