# Access Compliance Report

## Public Rights-of-Way

### (Curb Ramps)

Intersection ID: 13722	Main Street: BASCOM_ST	Cross Street: COMMONWEALTH_AV	Location: S
ADA ID: 6F3BF03EFA84	Ramp Type: Directional1	Initial Pass/Fail: Fail	Overall Compliance: No
Codes/Mitigation Info/Possible Solution		Field Measurements/Component Compliance	
Severity Score: 8.75

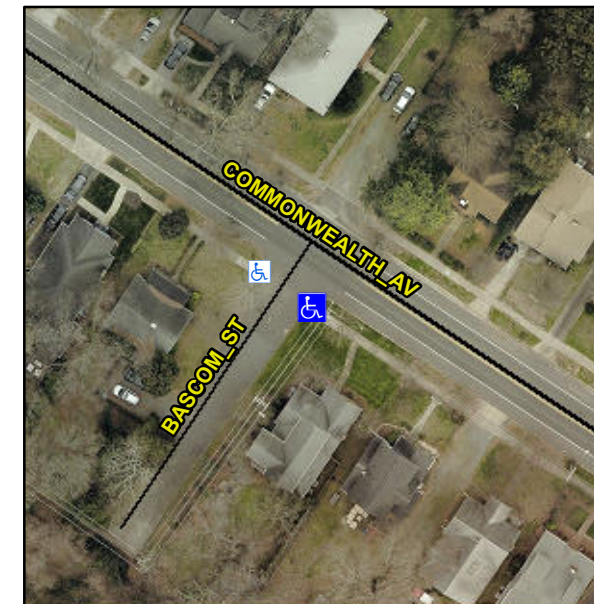
Compliance	Description	Data	Compliance	Description	Data
N/A	Ramp Length (in)	132.0	N/A	Grade Break?	N/A
No	Ramp Width (in)	46.0	N/A	Grade Break Slope (%)	0.0
Yes	Ramp Slope (%)	5.7	N/A	Grade Break XSlope (%)	0.0
Yes	Ramp XSlope (%)	0.3			
N/A	Flare Type LT	N/A	N/A	Flare Type RT	N/A
N/A	Flare Slope LT (%)	N/A	N/A	Flare Slope RT (%)	0.0
N/A	Flare Traversable LT?	N/A	N/A	Flare Traversable RT?	N/A
N/A	Landing Length (in)	0.0	N/A	DWS Provided?	N/A
N/A	Landing Width (in)	0.0	N/A	DWS Contrast?	N/A
N/A	Landing Slope (%)	0.0	N/A	DWS Length (in)	N/A
N/A	Landing X Slope (%)	0.0	N/A	DWS Full Width?	N/A
N/A	Landing Curb? (Y/N)	N/A	N/A	DWS Offset LT (in)	N/A
N/A	Shared Landing?	N/A	N/A	DWS Offset RT (in)	N/A
N/A	Gutter Ponding?	0.0	N/A	Gutter Slope (%)	N/A
N/A	Gutter Lip Ht (in)	0.0	N/A	Gutter X Slope (%)	N/A
N/A	Painted X Walk1?	No		Road Slope (%)	6.4
	X Walk 1 Direction	To NW		Road X Slope (%)	2.3
	X Walk 1 Width (in)	N/A		Clear Space?	N/A

X Walk 1 Slope (%)	6.4	N/A	Clear Space to XWalk (in)	N/A
	X Walk 1 X Slope (%)	2.3	N/A	Storm Grate/Utility Hazard?	N/A
N/A	Ramp inside XWalk1?	N/A		Storm Grate/Utility Type	
N/A	Any Obstructions?	N/A			N/A
	Obstruction Type		Yes	Surface Condition? (G/P)	Good
			N/A	Curb Slope (%)	7.1

**Remove & Replace Entire Ramp.**
