Access Compliance Report

Public Rights-of-Way

(Curb Ramps)

Intersection ID: 8804	Main Street: OREGON_ST	Cross Street: ROZZELLES_FERRY_RD	Location: S
ADA ID: 6F4B4F529929	Ramp Type: BlendTrans1	Initial Pass/Fail: Fail	Overall Compliance: No
		Severity Score: 10

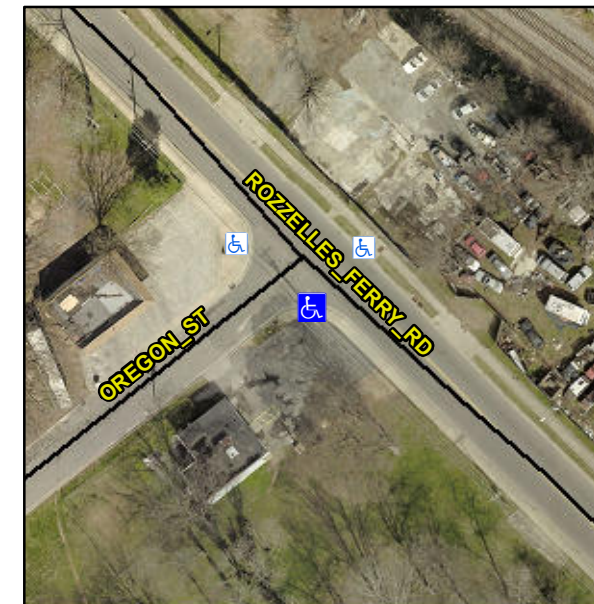
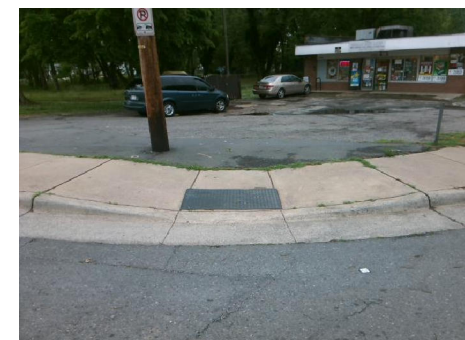
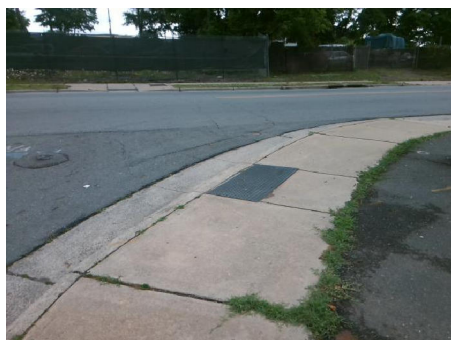
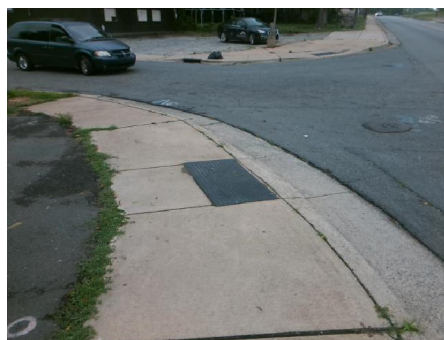
Not Found, R304.5.1, R304.5.3

Compliance	Description	Data	Compliance	Description	Data
N/A	Ramp Length (in)	61.0	Yes	BlendTrans Slope (%)	2.2
No	Ramp Width (in)	42.0	No	BlendTrans XSlope (%)	4.8
N/A	Flare Type LT	N/A	N/A	Flare Type RT	N/A
N/A	Flare Slope LT (%)	N/A	N/A	Flare Slope RT (%)	N/A
N/A	Flare Traversable LT?	N/A	N/A	Flare Traversable RT?	N/A
N/A	Landing Length (in)	N/A	N/A	DWS Provided?	N/A
N/A	Landing Width (in)	N/A	N/A	DWS Contrast?	N/A
N/A	Landing Slope (%)	N/A	N/A	DWS Length (in)	N/A
N/A	Landing X Slope (%)	N/A	N/A	DWS Full Width?	N/A
N/A	Landing Curb? (Y/N)	N/A	N/A	DWS Offset (in)	N/A
N/A	Shared Landing?	N/A			
N/A	Gutter Ponding?	N/A	N/A	Gutter Slope (%)	N/A
N/A	Gutter Lip Ht (in)	1.0	N/A	Gutter X Slope (%)	N/A
N/A	Painted X Walk1?	No	N/A	Painted X Walk2?	No
	X Walk 1 Direction	To NE		X Walk 2 Direction	To NW
	X Walk 1 Width (in)	N/A		X Walk 2 Width (in)	N/A
	X Walk 1 Slope (%)	8.0		X Walk 2 Slope (%)	2.0
	X Walk 1 X Slope (%)	1.3		X Walk 2 X Slope (%)	7.6

N/A	Ramp inside XWalk1?	N/A	N/A	Ramp inside XWalk2?	N/A
	Road Slope (%)	3.2		Clear Space?	N/A
	Road X Slope (%)	7.4	N/A	Clear Space to XWalk (in)	N/A
N/A	Any Obstructions?	N/A	N/A	Storm Grate/Utility Hazard?	N/A
	Obstruction Type			Storm Grate/Utility Type	
		N/A			N/A
			Yes	Surface Condition? (G/P)	Good
			No	Curb Slope (%)	12.5

Remove & Replace Curb Ramp With Two New Directional Ramps or Equivalent.
