# Access Compliance Report

## Public Rights-of-Way

### (Curb Ramps)

Intersection ID: 3786	Main Street: GALLOWAY_RD	Cross Street: MALLARD_CREEK_RD	Location: N
ADA ID: 6F4E842D472F	Ramp Type: Perp	Initial Pass/Fail: Fail	Overall Compliance: No
Severity Score: 21.25			
Codes/Mitigation Info/Possible Solution		Field Measurements/Component Compliance

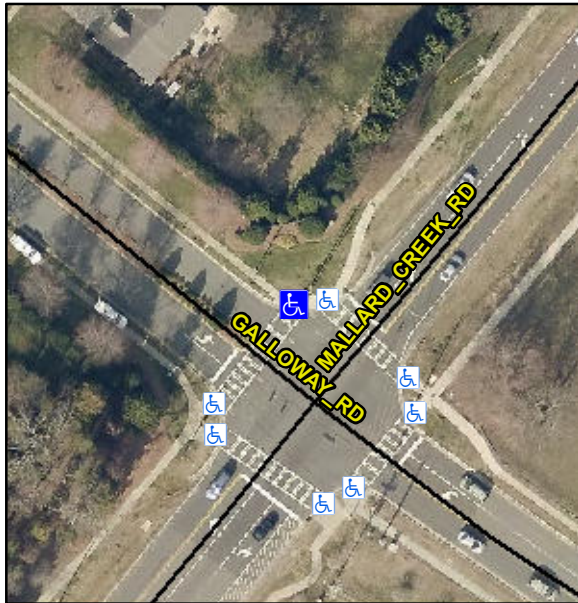
Compliance	Description	Data	Compliance	Description	Data
N/A	Ramp Length (in)	71.0	No	Ramp Slope (%)	8.8
No	Ramp Width (in)	46.5	Yes	Ramp XSlope (%)	1.0
N/A	Flare Type LT	N/A	N/A	Flare Type RT	N/A
N/A	Flare Slope LT (%)	N/A	N/A	Flare Slope RT (%)	N/A
N/A	Flare Traversable LT?	N/A	N/A	Flare Traversable RT?	N/A
N/A	Landing Length (in)	N/A	N/A	DWS Provided?	N/A
N/A	Landing Width (in)	N/A	N/A	DWS Contrast?	N/A
N/A	Landing Slope (%)	N/A	N/A	DWS Length (in)	N/A
N/A	Landing X Slope (%)	N/A	N/A	DWS Full Width?	N/A
N/A	Landing Curb? (Y/N)	N/A	N/A	DWS Offset (in)	N/A
N/A	Shared Landing?	N/A			
N/A	Gutter Ponding?	N/A	N/A	Gutter Slope (%)	N/A
N/A	Gutter Lip Ht (in)	N/A	N/A	Gutter X Slope (%)	N/A
N/A	Painted X Walk1?	Yes	N/A	Painted X Walk2?	N/A
	X Walk 1 Direction	To SW		X Walk 2 Direction	N/A
N/A	X Walk 1 Width (in)	112.0	N/A	X Walk 2 Width (in)	N/A
	X Walk 1 Slope (%)	4.4		X Walk 2 Slope (%)	N/A
	X Walk 1 X Slope (%)	0.9		X Walk 2 X Slope (%)	N/A

N/A	Ramp inside XWalk1?	Yes	N/A	Ramp inside XWalk2?	N/A
	Road Slope (%)	N/A	N/A	Clear Space?	N/A
	Road X Slope (%)	N/A	N/A	Clear Space to XWalk (in)	N/A
N/A	Any Obstructions?	N/A	N/A	Storm Grate/Utility Hazard?	N/A
	Obstruction Type			Storm Grate/Utility Type	
		N/A			N/A
		Yes		Surface Condition? (G/P)	Good

**Remove & Replace Entire Ramp.**

**R304.5.1, R304.2.2**
