# Access Compliance Report

## Public Rights-of-Way

### (Curb Ramps)

Intersection ID: 49251	Main Street: RIDGE_PATH_LN	Cross Street: PROSPERITY_RIDGE_RD	Location: S
ADA ID: 6F67DB9ABC87	Ramp Type: Perp	Initial Pass/Fail: Pass	Overall Compliance: No
Severity Score: 2.75			
Codes/Mitigation Info/Possible Solution		Field Measurements/Component Compliance

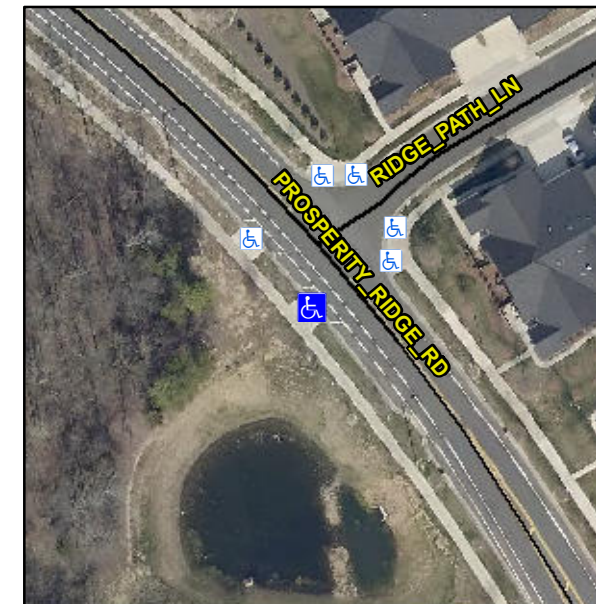
**R304.5.3, R304.2.3**

Compliance	Description	Data	Compliance	Description	Data
N/A	Ramp Length (in)	96.0	Yes	Ramp Slope (%)	8.3
Yes	Ramp Width (in)	48.0	No	Ramp XSlope (%)	2.9
N/A	Flare Type LT	Sloped	N/A	Flare Type RT	N/A
N/A	Flare Slope LT (%)	5.6	No	Flare Slope RT (%)	10.6
N/A	Flare Traversable LT?	Yes	N/A	Flare Traversable RT?	Yes
Yes	Landing Length (in)	71.0	Yes	DWS Provided?	Yes
Yes	Landing Width (in)	48.0	Yes	DWS Contrast?	Yes
Yes	Landing Slope (%)	0.5	Yes	DWS Length (in)	24.0
Yes	Landing X Slope (%)	1.8	Yes	DWS Full Width?	Yes
N/A	Landing Curb? (Y/N)	No	Yes	DWS Offset (in)	0.0
N/A	Shared Landing?	No			
Yes	Gutter Ponding?	No	Yes	Gutter Slope (%)	3.6
Yes	Gutter Lip Ht (in)	0.0	Yes	Gutter X Slope (%)	2.0
N/A	Painted X Walk1?	No	N/A	Painted X Walk2?	N/A
	X Walk 1 Direction	To NE		X Walk 2 Direction	N/A
N/A	X Walk 1 Width (in)	N/A	N/A	X Walk 2 Width (in)	N/A
	X Walk 1 Slope (%)	4.4		X Walk 2 Slope (%)	N/A
	X Walk 1 X Slope (%)	2.6		X Walk 2 X Slope (%)	N/A

N/A	Ramp inside XWalk1?	N/A	N/A	Ramp inside XWalk2?	N/A
	Road Slope (%)	N/A	N/A	Clear Space?	Yes
	Road X Slope (%)	N/A	N/A	Clear Space to XWalk (in)	N/A
Yes	Any Obstructions?	No	Yes	Storm Grate/Utility Hazard?	No
	Obstruction Type			Storm Grate/Utility Type	
		N/A			N/A
			Yes	Surface Condition? (G/P)	Good

**Remove & Replace Entire Ramp.**

Total Cost: \$ 1850.00
