Access Compliance Report

Public Rights-of-Way

(Curb Ramps)

Intersection ID: 29420	Main Street: BRADSTREET COMMONS_WY	Cross Street: SALINGER_WY	Location: N
ADA ID: 6F695BE8AFAA	Ramp Type: Perp	Initial Pass/Fail: Fail	Overall Compliance: No
Severity Score: 33.75			
Codes/Mitigation Info/Possible Solution		Field Measurements/Component Compliance

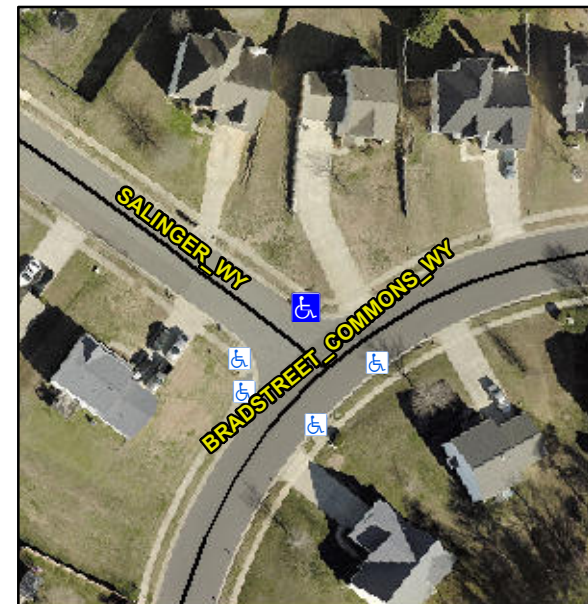
Not Found, R304.5.1, R304.5.3

Compliance	Description	Data	Compliance	Description	Data
N/A	Ramp Length (in)	48.0	Yes	Ramp Slope (%)	6.9
No	Ramp Width (in)	39.0	No	Ramp XSlope (%)	13.2
N/A	Flare Type LT	N/A	N/A	Flare Type RT	N/A
N/A	Flare Slope LT (%)	N/A	N/A	Flare Slope RT (%)	N/A
N/A	Flare Traversable LT?	N/A	N/A	Flare Traversable RT?	N/A
N/A	Landing Length (in)	N/A	N/A	DWS Provided?	N/A
N/A	Landing Width (in)	N/A	N/A	DWS Contrast?	N/A
N/A	Landing Slope (%)	N/A	N/A	DWS Length (in)	N/A
N/A	Landing X Slope (%)	N/A	N/A	DWS Full Width?	N/A
N/A	Landing Curb? (Y/N)	N/A	N/A	DWS Offset (in)	N/A
N/A	Shared Landing?	N/A			
N/A	Gutter Ponding?	N/A	N/A	Gutter Slope (%)	N/A
N/A	Gutter Lip Ht (in)	N/A	N/A	Gutter X Slope (%)	N/A
N/A	Painted X Walk1?	No	N/A	Painted X Walk2?	N/A
	X Walk 1 Direction	To SW		X Walk 2 Direction	N/A
N/A	X Walk 1 Width (in)	N/A	N/A	X Walk 2 Width (in)	N/A
	X Walk 1 Slope (%)	3.7		X Walk 2 Slope (%)	N/A
	X Walk 1 X Slope (%)	7.7		X Walk 2 X Slope (%)	N/A

N/A	Ramp inside XWalk1?	N/A	N/A	Ramp inside XWalk2?	N/A
	Road Slope (%)	N/A	N/A	Clear Space?	N/A
	Road X Slope (%)	N/A	N/A	Clear Space to XWalk (in)	N/A
N/A	Any Obstructions?	N/A	N/A	Storm Grate/Utility Hazard?	N/A
	Obstruction Type			Storm Grate/Utility Type	
		N/A			N/A
			Yes	Surface Condition? (G/P)	Good

Remove & Replace Entire Ramp.
