# Access Compliance Report

## Public Rights-of-Way

| Intersection ID: 5544 | Main Street: NORTHWOODS_FOREST_DR | Cross Street: SILVERBERRY_CT | Location: | N |
| ADA ID: 6F6D8EA17167 | Ramp Type: Perp | Initial Pass/Fail: Fail | Overall Compliance: No | Severity Score: 12.5 |

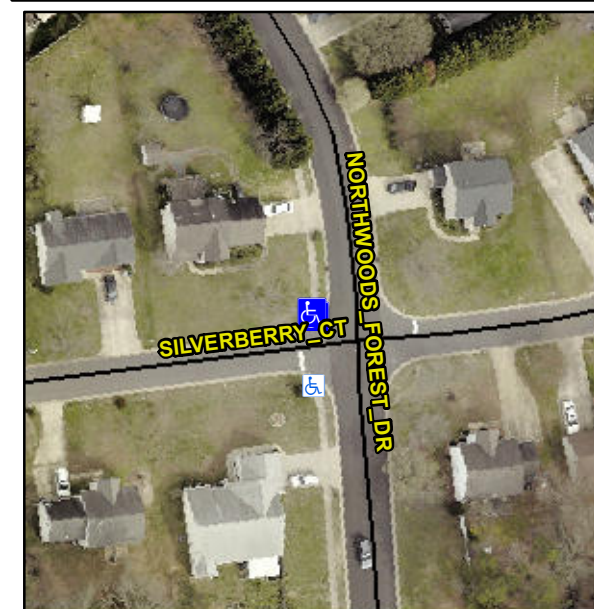
**Not Found, R304.5.3**

| Compliance | Description | Data | Compliance | Description | Data |
|---|---|---|---|---|---|
| Yes | Ramp Width (in) | 48.0 | No | Ramp XSlope (%) | 5.3 |

**Remove & Replace Entire Ramp.**

Total Cost: \$ 1850.00
