Access Compliance Report

Public Rights-of-Way

(Curb Ramps)

Intersection ID: 11956	Main Street: E_9TH_ST	Cross Street: N_COLLEGE_ST	Location: N
ADA ID: 6F6EE0AFBDDE	Ramp Type: PerpDiag	Initial Pass/Fail: Fail	Overall Compliance: No
		Severity Score: 12.5

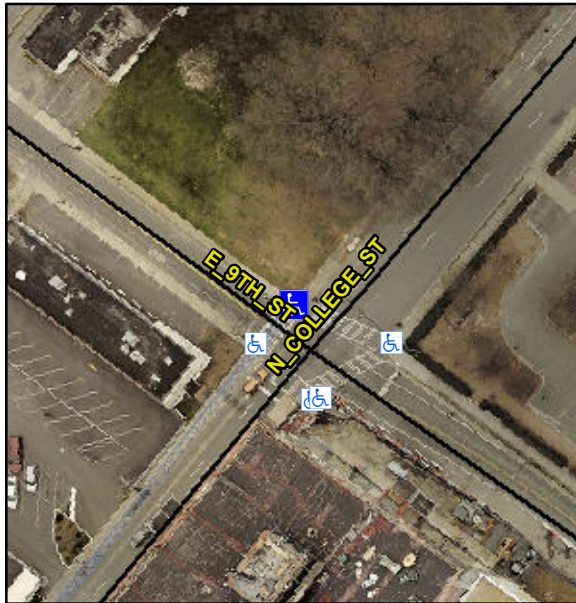
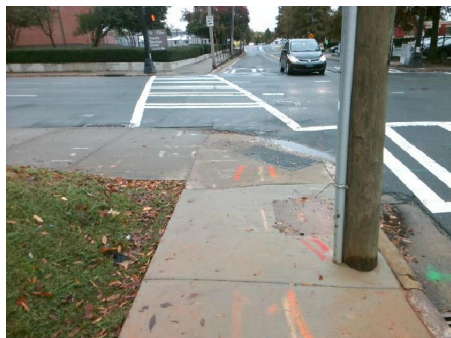
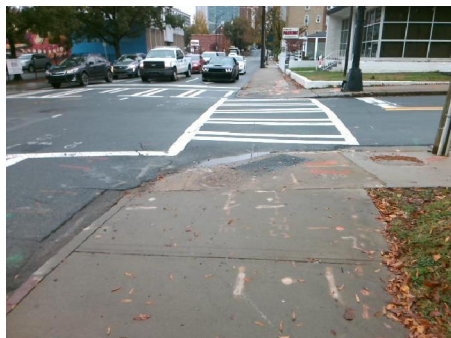
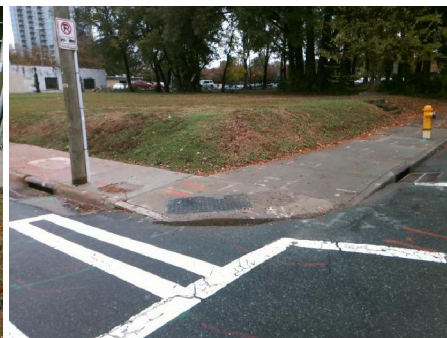
Not Found, R304.2.2

Compliance	Description	Data	Compliance	Description	Data
N/A	Ramp Length (in)	51.0	No	Ramp Slope (%)	9.1
Yes	Ramp Width (in)	48.0	Yes	Ramp XSlope (%)	0.9
N/A	Flare Type LT	N/A	N/A	Flare Type RT	N/A
N/A	Flare Slope LT (%)	N/A	N/A	Flare Slope RT (%)	N/A
N/A	Flare Traversable LT?	N/A	N/A	Flare Traversable RT?	N/A
N/A	Landing Length (in)	N/A	N/A	DWS Provided?	N/A
N/A	Landing Width (in)	N/A	N/A	DWS Contrast?	N/A
N/A	Landing Slope (%)	N/A	N/A	DWS Length (in)	N/A
N/A	Landing X Slope (%)	N/A	N/A	DWS Full Width?	N/A
N/A	Landing Curb? (Y/N)	N/A	N/A	DWS Offset (in)	N/A
N/A	Shared Landing?	N/A			
N/A	Gutter Ponding?	Yes	N/A	Gutter Slope (%)	N/A
N/A	Gutter Lip Ht (in)	N/A	N/A	Gutter X Slope (%)	N/A
N/A	Painted X Walk1?	Yes	N/A	Painted X Walk2?	Yes
	X Walk 1 Direction	To SW		X Walk 2 Direction	To SE
N/A	X Walk 1 Width (in)	95.0	N/A	X Walk 2 Width (in)	95.0
	X Walk 1 Slope (%)	2.9		X Walk 2 Slope (%)	2.6
	X Walk 1 X Slope (%)	1.3		X Walk 2 X Slope (%)	0.0

N/A	Ramp inside XWalk1?	Yes	N/A	Ramp inside XWalk2?	Yes
	Road Slope (%)	2.3	N/A	Clear Space?	N/A
	Road X Slope (%)	4.4	N/A	Clear Space to XWalk (in)	N/A
N/A	Any Obstructions?	N/A	N/A	Storm Grate/Utility Hazard?	N/A
	Obstruction Type			Storm Grate/Utility Type	
		N/A			N/A
		Yes		Surface Condition? (G/P)	Good

Remove & Replace Curb Ramp With Two New Directional Ramps or Equivalent.
