# Access Compliance Report

## Public Rights-of-Way

### (Curb Ramps)

Intersection ID: N/A	Main Street: HOUSTON_FIELD_CT	Cross Street: SOUTHMORE_DR	Location: SE
ADA ID: 6F73523E54BB	Ramp Type: Directional1	Initial Pass/Fail: Fail	Overall Compliance: No
Codes/Mitigation Info/Possible Solution		Field Measurements/Component Compliance	
Severity Score: 37.5

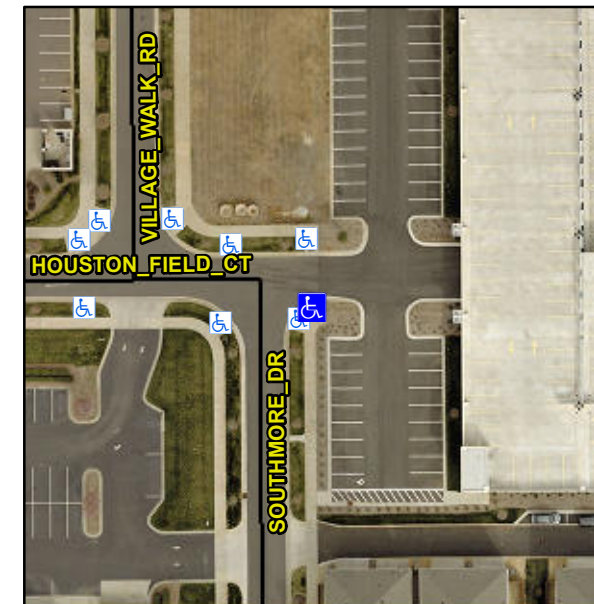
Compliance	Description	Data	Compliance	Description	Data
N/A	Ramp Length (in)	73.0	N/A	Grade Break?	N/A
Yes	Ramp Width (in)	72.0	N/A	Grade Break Slope (%)	0.0
No	Ramp Slope (%)	8.7	N/A	Grade Break XSlope (%)	0.0
No	Ramp XSlope (%)	7.0			
N/A	Flare Type LT	N/A	N/A	Flare Type RT	N/A
N/A	Flare Slope LT (%)	N/A	N/A	Flare Slope RT (%)	0.0
N/A	Flare Traversable LT?	N/A	N/A	Flare Traversable RT?	N/A
N/A	Landing Length (in)	0.0	N/A	DWS Provided?	N/A
N/A	Landing Width (in)	0.0	N/A	DWS Contrast?	N/A
N/A	Landing Slope (%)	0.0	N/A	DWS Length (in)	N/A
N/A	Landing X Slope (%)	0.0	N/A	DWS Full Width?	N/A
N/A	Landing Curb? (Y/N)	N/A	N/A	DWS Offset LT (in)	N/A
N/A	Shared Landing?	N/A	N/A	DWS Offset RT (in)	N/A
N/A	Gutter Ponding?	0.0	N/A	Gutter Slope (%)	N/A
N/A	Gutter Lip Ht (in)	0.0	N/A	Gutter X Slope (%)	N/A
N/A	Painted X Walk1?	No		Road Slope (%)	4.0
	X Walk 1 Direction	To N		Road X Slope (%)	2.6
	X Walk 1 Width (in)	N/A		Clear Space?	N/A

X Walk 1 Slope (%)	4.0	N/A	Clear Space to XWalk (in)	N/A
	X Walk 1 X Slope (%)	2.6	N/A	Storm Grate/Utility Hazard?	N/A
N/A	Ramp inside XWalk1?	N/A		Storm Grate/Utility Type	
N/A	Any Obstructions?	N/A			N/A
	Obstruction Type		Yes	Surface Condition? (G/P)	Good
			N/A	Curb Slope (%)	4.6

Possible Solutions:

**Remove & Replace Entire Ramp.**

**R304.2.2, R304.5.3**

\$ 1600.00
