# Access Compliance Report

## Public Rights-of-Way

### (Curb Ramps)

Intersection ID: 42757	Main Street: ELAM_CT	Cross Street: LEES_CROSSING_DR	Location: W
ADA ID: 6F782192A124	Ramp Type: PerpDiag	Initial Pass/Fail: Fail	Overall Compliance: No
Severity Score: 46.25			
Codes/Mitigation Info/Possible Solution		Field Measurements/Component Compliance

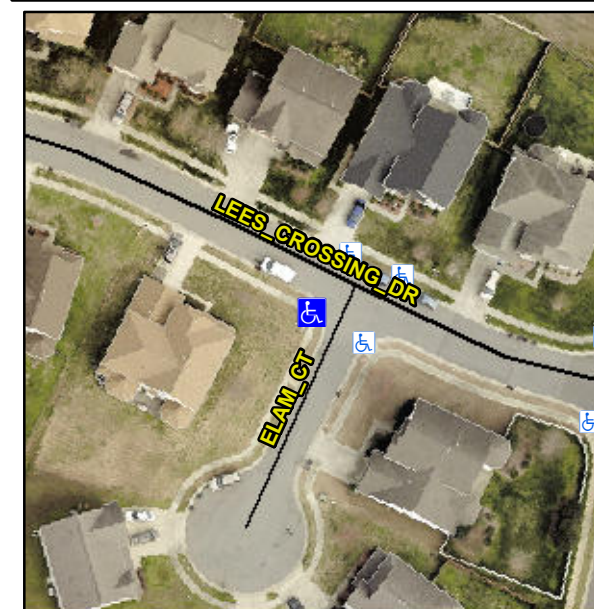
PROW/ADA:

**Not Found, R304.5.1, R304.2.2, R304.5.3**

Compliance	Description	Data	Compliance	Description	Data
N/A	Ramp Length (in)	44.0	No	Ramp Slope (%)	10.8
No	Ramp Width (in)	36.0	No	Ramp XSlope (%)	7.9
N/A	Flare Type LT	N/A	N/A	Flare Type RT	N/A
N/A	Flare Slope LT (%)	N/A	N/A	Flare Slope RT (%)	N/A
N/A	Flare Traversable LT?	N/A	N/A	Flare Traversable RT?	N/A
N/A	Landing Length (in)	N/A	N/A	DWS Provided?	N/A
N/A	Landing Width (in)	N/A	N/A	DWS Contrast?	N/A
N/A	Landing Slope (%)	N/A	N/A	DWS Length (in)	N/A
N/A	Landing X Slope (%)	N/A	N/A	DWS Full Width?	N/A
N/A	Landing Curb? (Y/N)	N/A	N/A	DWS Offset (in)	N/A
N/A	Shared Landing?	N/A			
N/A	Gutter Ponding?	N/A	N/A	Gutter Slope (%)	N/A
N/A	Gutter Lip Ht (in)	N/A	N/A	Gutter X Slope (%)	N/A
N/A	Painted X Walk1?	No	N/A	Painted X Walk2?	No
	X Walk 1 Direction	To SE		X Walk 2 Direction	To NE
N/A	X Walk 1 Width (in)	N/A	N/A	X Walk 2 Width (in)	N/A
	X Walk 1 Slope (%)	6.0		X Walk 2 Slope (%)	2.9
	X Walk 1 X Slope (%)	3.0		X Walk 2 X Slope (%)	7.4

N/A	Ramp inside XWalk1?	N/A	N/A	Ramp inside XWalk2?	N/A
	Road Slope (%)	5.9	N/A	Clear Space?	N/A
	Road X Slope (%)	3.8	N/A	Clear Space to XWalk (in)	N/A
N/A	Any Obstructions?	N/A	N/A	Storm Grate/Utility Hazard?	N/A
	Obstruction Type			Storm Grate/Utility Type	
		N/A			N/A
			Yes	Surface Condition? (G/P)	Good

Possible Solutions:

**Remove & Replace Curb Ramp With Two New Directional Ramps or Equivalent.**
