# Access Compliance Report

## Public Rights-of-Way

### (Curb Ramps)

Intersection ID: 49697	Main Street: HIGHLAND_MEADOW_RD	Cross Street: MADISON_HILL_CT	Location: SW
ADA ID: 6F798F348102	Ramp Type: Perp	Initial Pass/Fail: Fail	Overall Compliance: No
Severity Score: 21.25			
Codes/Mitigation Info/Possible Solution		Field Measurements/Component Compliance

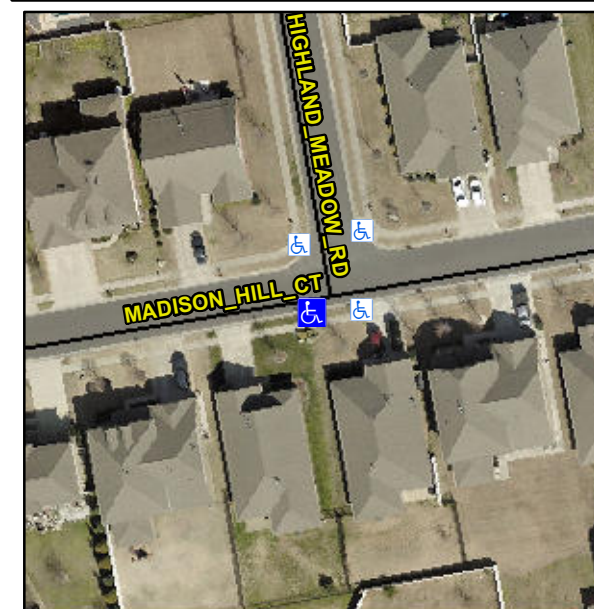
**Not Found, R304.5.1, R304.2.2**

Compliance	Description	Data	Compliance	Description	Data
N/A	Ramp Length (in)	48.0	No	Ramp Slope (%)	11.1
No	Ramp Width (in)	47.0	Yes	Ramp XSlope (%)	1.1
N/A	Flare Type LT	N/A	N/A	Flare Type RT	N/A
N/A	Flare Slope LT (%)	N/A	N/A	Flare Slope RT (%)	N/A
N/A	Flare Traversable LT?	N/A	N/A	Flare Traversable RT?	N/A
N/A	Landing Length (in)	N/A	N/A	DWS Provided?	N/A
N/A	Landing Width (in)	N/A	N/A	DWS Contrast?	N/A
N/A	Landing Slope (%)	N/A	N/A	DWS Length (in)	N/A
N/A	Landing X Slope (%)	N/A	N/A	DWS Full Width?	N/A
N/A	Landing Curb? (Y/N)	N/A	N/A	DWS Offset (in)	N/A
N/A	Shared Landing?	N/A			
N/A	Gutter Ponding?	N/A	N/A	Gutter Slope (%)	N/A
N/A	Gutter Lip Ht (in)	N/A	N/A	Gutter X Slope (%)	N/A
N/A	Painted X Walk1?	No	N/A	Painted X Walk2?	N/A
	X Walk 1 Direction	To N		X Walk 2 Direction	N/A
N/A	X Walk 1 Width (in)	N/A	N/A	X Walk 2 Width (in)	N/A
	X Walk 1 Slope (%)	2.9		X Walk 2 Slope (%)	N/A
	X Walk 1 X Slope (%)	1.0		X Walk 2 X Slope (%)	N/A

N/A	Ramp inside XWalk1?	N/A	N/A	Ramp inside XWalk2?	N/A
	Road Slope (%)	N/A	N/A	Clear Space?	N/A
	Road X Slope (%)	N/A	N/A	Clear Space to XWalk (in)	N/A
N/A	Any Obstructions?	N/A	N/A	Storm Grate/Utility Hazard?	N/A
	Obstruction Type			Storm Grate/Utility Type	
		N/A			N/A
			Yes	Surface Condition? (G/P)	Good

Possible Solutions:

**Remove & Replace Entire Ramp.**
