Access Compliance Report

Public Rights-of-Way

(Curb Ramps)

Intersection ID: 16828	Main Street: BUCKNELL_AV	Cross Street: SELWYN_AV	Location: SE
ADA ID: 6F7DC32EA2FA	Ramp Type: Perp	Initial Pass/Fail: Fail	Overall Compliance: No
Severity Score: 12.5			
Codes/Mitigation Info/Possible Solution		Field Measurements/Component Compliance

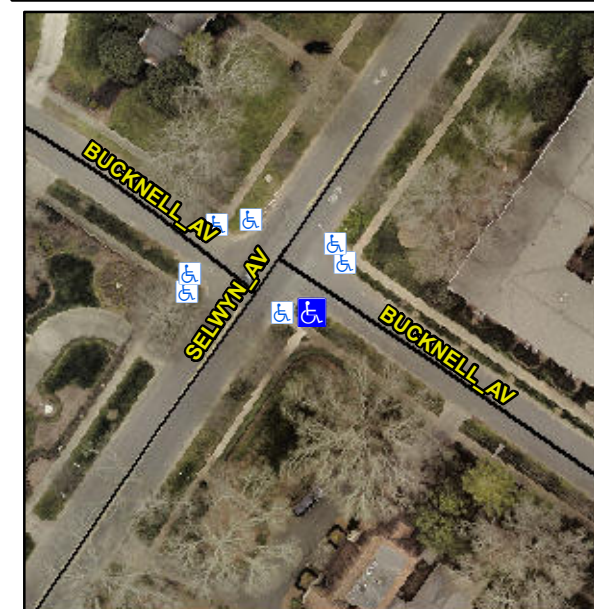
Not Found, R304.2.2

Compliance	Description	Data	Compliance	Description	Data
N/A	Ramp Length (in)	89.0	No	Ramp Slope (%)	10.9
Yes	Ramp Width (in)	53.0	Yes	Ramp XSlope (%)	1.4
N/A	Flare Type LT	N/A	N/A	Flare Type RT	N/A
N/A	Flare Slope LT (%)	N/A	N/A	Flare Slope RT (%)	N/A
N/A	Flare Traversable LT?	N/A	N/A	Flare Traversable RT?	N/A
N/A	Landing Length (in)	N/A	N/A	DWS Provided?	N/A
N/A	Landing Width (in)	N/A	N/A	DWS Contrast?	N/A
N/A	Landing Slope (%)	N/A	N/A	DWS Length (in)	N/A
N/A	Landing X Slope (%)	N/A	N/A	DWS Full Width?	N/A
N/A	Landing Curb? (Y/N)	N/A	N/A	DWS Offset (in)	N/A
N/A	Shared Landing?	N/A			
N/A	Gutter Ponding?	N/A	N/A	Gutter Slope (%)	N/A
N/A	Gutter Lip Ht (in)	N/A	N/A	Gutter X Slope (%)	N/A
N/A	Painted X Walk1?	No	N/A	Painted X Walk2?	N/A
	X Walk 1 Direction	To NE		X Walk 2 Direction	N/A
N/A	X Walk 1 Width (in)	N/A	N/A	X Walk 2 Width (in)	N/A
	X Walk 1 Slope (%)	4.0		X Walk 2 Slope (%)	N/A
	X Walk 1 X Slope (%)	1.3		X Walk 2 X Slope (%)	N/A

N/A	Ramp inside XWalk1?	N/A	N/A	Ramp inside XWalk2?	N/A
	Road Slope (%)	N/A	N/A	Clear Space?	N/A
	Road X Slope (%)	N/A	N/A	Clear Space to XWalk (in)	N/A
N/A	Any Obstructions?	N/A	N/A	Storm Grate/Utility Hazard?	N/A
	Obstruction Type			Storm Grate/Utility Type	
		N/A			N/A
			Yes	Surface Condition? (G/P)	Good

Remove & Replace Entire Ramp.

Total Cost: \$ 1850.00
