Access Compliance Report Public Rights-of-Way (Curb Ramps)

Intersection ID: 19130 Main Street: BARCLAY_DOWNS_DR Cross Street: INVERNESS_RD Location: N

ADA ID: 6F898A2F7A22 Ramp Type: PerpDiag Initial Pass/Fail: Fail Overall Compliance: No Severity Score: 26.25

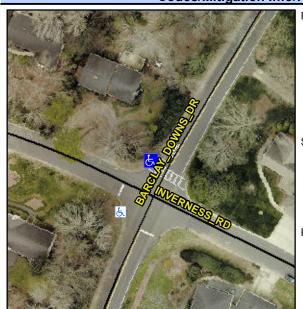
Not Found, R304.2.2, R304.5.3

Data		liance Description	Data
N/A	Ramp Length (in)	54.0	No	Ramp Slope (%)	13.5
Yes	Ramp Width (in)	49.5	No	Ramp XSlope (%)	4.1
N/A	Flare Type LT	N/A	N/A	Flare Type RT	N/A
N/A	Flare Slope LT (%)	N/A	N/A	Flare Slope RT (%)	N/A
N/A	Flare Traversable LT?	N/A	N/A	Flare Traversable RT?	N/A
N/A	Landing Length (in)	N/A	N/A	DWS Provided?	N/A
N/A	Landing Width (in)	N/A	N/A	DWS Contrast?	N/A
N/A	Landing Slope (%)	N/A	N/A	DWS Length (in)	N/A
N/A	Landing X Slope (%)	N/A	N/A	DWS Full Width?	N/A
N/A	Landing Curb? (Y/N)	N/A	N/A	DWS Offset (in)	N/A
N/A	Shared Landing?	N/A			
N/A	Gutter Ponding?	N/A	N/A	Gutter Slope (%)	N/A
N/A	Gutter Lip Ht (in)	N/A	N/A	Gutter X Slope (%)	N/A
N/A	Painted X Walk1?	No	N/A	Painted X Walk2?	Yes
	X Walk 1 Direction	To SW		X Walk 2 Direction	To SE
N/A	X Walk 1 Width (in)	N/A	N/A	X Walk 2 Width (in)	111.5
	X Walk 1 Slope (%)	5.9		X Walk 2 Slope (%)	3.4
	X Walk 1 X Slope (%)	5.0		X Walk 2 X Slope (%)	6.5

N/A	Ramp inside XWalk1?	N/A	N/A	Ramp inside XWalk2?	Yes
	Road Slope (%)	4.7	N/A	Clear Space?	N/A
	Road X Slope (%)	5.4	N/A	Clear Space to XWalk (in)	N/A
N/A	Any Obstructions?	N/A	N/A	Storm Grate/Utility Hazard?	N/A
	Obstruction Type		l	Storm Grate/Utility Type	
		N/A			N/A
			Yes	Surface Condition? (G/P)	Good

Remove & Replace Curb Ramp With Two New Directional Ramps or Equivalent.

Total Cost: \$ 3200.00
